1-17 Viewing Inside an Irradiated Fuel Assembly

— Development of a Non-Destructive Post-Irradiation Examination Technique Using High-Energy X-ray Computer Tomography —

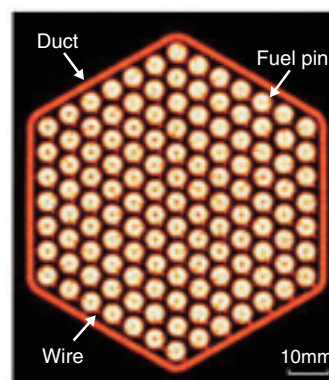
Fig.1-44 X-ray CT image of irradiated fuel assembly
The wrapper tube, cladding, fuel pins and wrapping wire can be distinctly seen in this figure.

As a result, a clear cross sectional CT image (Fig.1-44) of the fuel assembly irradiated to high burn up can be obtained. Analyzing this image enables measurement of the displacement of fuel pins in the assembly and the change of sodium flow area.

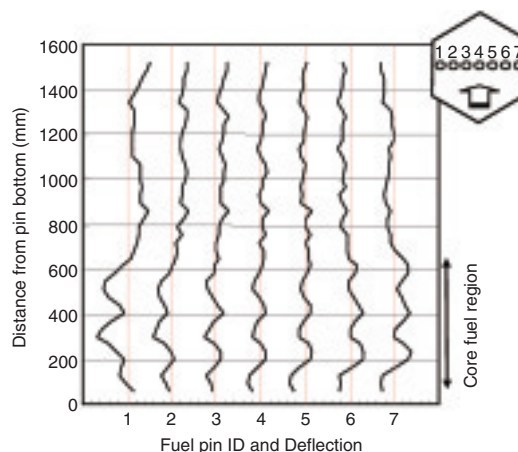
Fig.1-45 Longitudinal deformations of fuel pins

This figure shows the longitudinal deformations of an irradiated fuel assembly. The deformations of the core fuel region are significant.

Fig.1-45 illustrates the longitudinal deformations of 7 fuel pins located in the center line of the fuel assembly. As shown in this figure, the deformations of fuel pins at the core fuel region are significant compared with the deformations of fuel pins at other regions. This behavior was caused by the irradiation creep of the core. Evaluation of the temperature effects on the fuel assembly will be aided using these data.
