## 4-16 R&D of High Power Neutron Sources

### — Micropit Formation by Pressure Wave in Mercury Target —

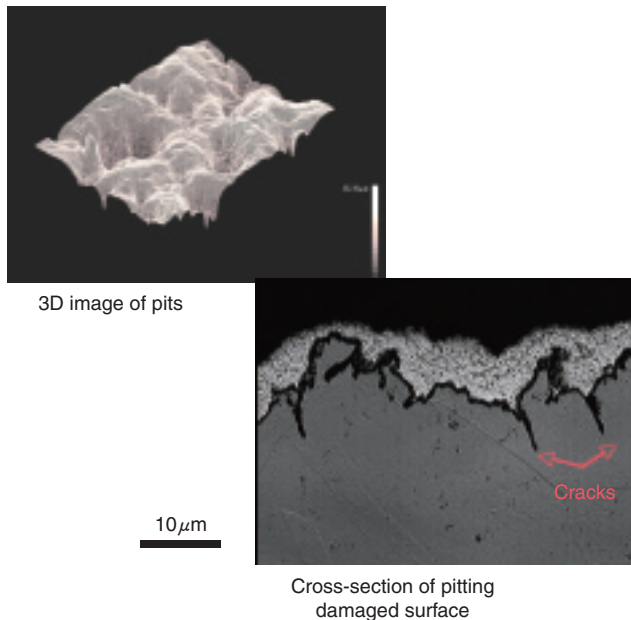
**Fig.4-36 Micrographs taken by a laser microscope**

The pitting damage was observed after  $10^6$  pulses whose amplitude is equivalent to the pressure pulse induced by MW-class proton beam injection. Cracks were propagated under the bottom of pits.

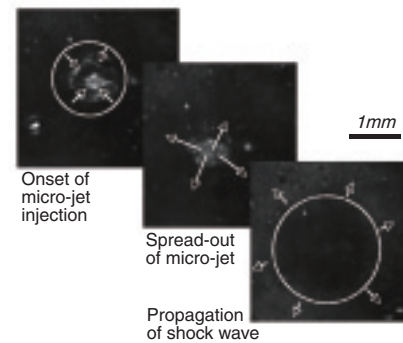
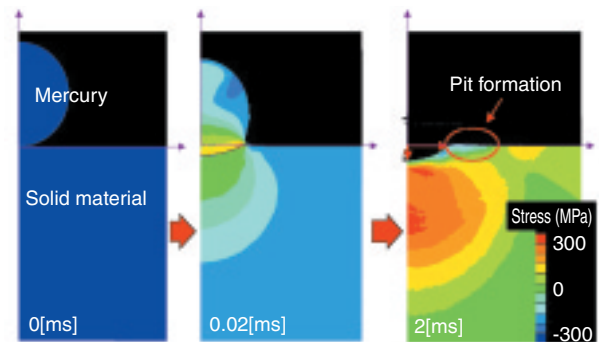
**Fig.4-37 Micro-jet impact analysis with impact velocity (ca. 200 m/s) estimated from observing bubble collapse behavior describes well the pit formation.**

(a) Cavitation bubble collapse behavior

(b) Micro-jet impact analysis

cavitation bubble collapse behavior was observed by using a high-speed video camera, and also simulated numerically (Fig.4-37). Localized impact was quantitatively estimated through comparison between numerical simulation and experiment. A novel surface treatment technique that consists of carburizing and nitriding processes was developed. The treatment condition was optimized to achieve an improved surface layer with a suitable hardness gradient that can mitigate the pitting damage due to localized impacts, taking into account the stress distribution evaluated by micro-jet impact simulation. This surface improvement increases the lifetime of the mercury target vessel: the number of pulses before pitting damage becomes pronounced increases from  $10^6$  to  $10^7$ .
