14-1 Remote Nondestructive Examination of Steam Generator (SG) Heat Transfer Tubes

— SG Heat Transfer Tubes Integrity Confirmation by Eddy Current Test, Visualization and Gas Leak Tests —

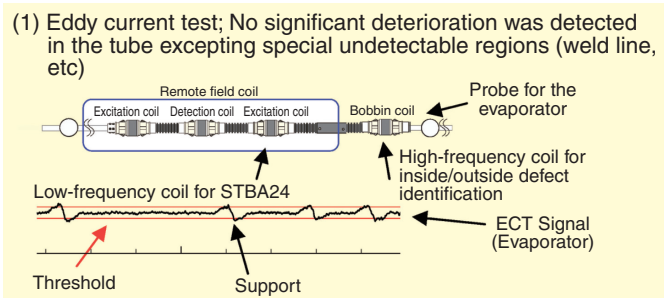
The ECT detection performance was improved using exciting frequencies optimized for evaporator and super-heater tubes using a technique based on improvements made in noise reduction tests. Also, the correlation between ECT

signal and tube thickness was checked by using test pieces. By comparing test results with records of the inspection at the time of manufacture, it was confirmed that no wall thinning occurred since the last inspection.

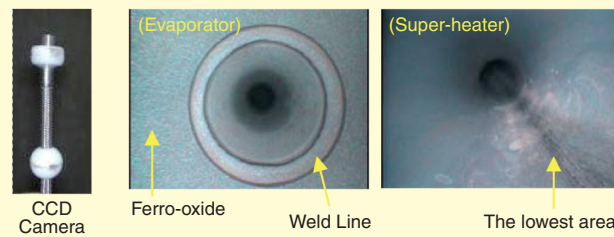
(2) Visual test; No corrosion was observed

The visual test using CCD camera was improved by increasing the camera resolution, by a better lighting, and by enhancing its insertion-ability. The CCD camera fixed speed insertion mechanism was newly developed to obtain accurate sensor location. The heat transfer tube down-comer area including welds was inspected as a typical heat transfer tube because its environment is the same as the other steam generator area. This test confirmed that there was no significant corrosion or defect.

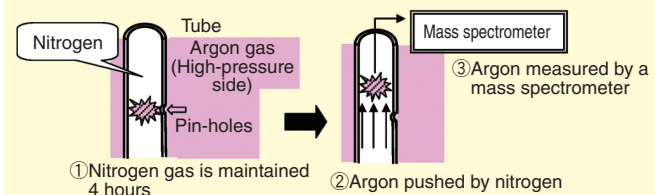
(3) Leak test; Argon gas was not detected; therefore, there are no penetration holes.

In the leak test, the argon gas concentration in a heat transfer tube was measured by a mass spectrometer. Argon gas was not detected, showing that there were no penetration holes.
