# 8-7 Investigation of Damage to Rock Mass in Gallery Excavation - Based on Seismic Velocity and Fracture Distribution around Gallery Wall -

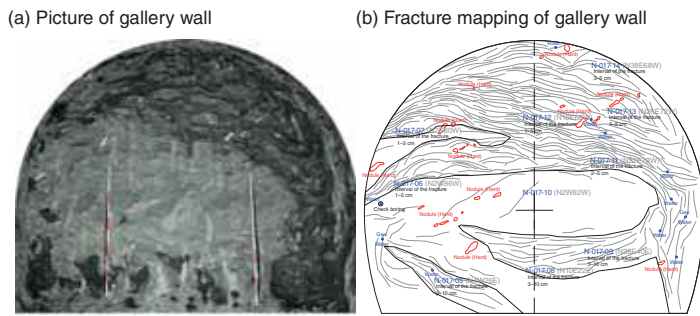
**Fig.8-17 Example of fractures induced by gallery excavation**  
Gray lines in (b) indicate fractures induced by gallery excavation.

In the construction of a deep underground gallery, fractures are induced around the gallery wall because of stress redistribution in response to excavation, as shown in Fig.8-17. In addition, because of these fractures, the hydraulic conductivity of the rock mass increases. Such a zone is called an excavation damaged zone (EDZ). To dispose of high-level radioactive waste, evaluation of an EDZ is important for safety assessment.

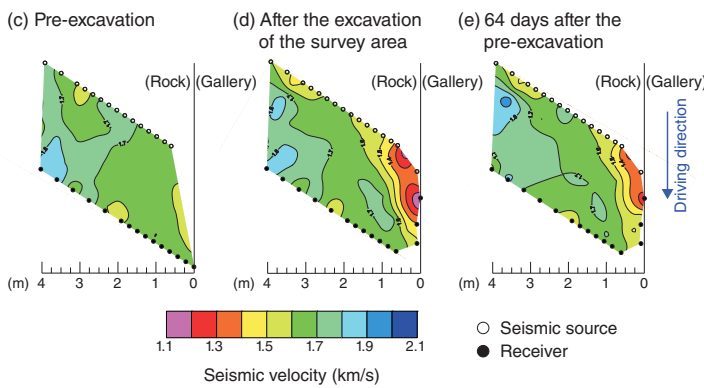
**Fig.8-18 Results of seismic tomography survey**  
Velocity contour map of rock mass around gallery wall.

The Horonobe Underground Research Laboratory is conducting a seismic tomography survey at the depth of each gallery (140 m, 250 m, and 350 m) to investigate the extent of an EDZ. Fig.8-18 shows how seismic velocity changes in response to excavation. These results were obtained from a seismic tomography survey performed in the 250 m gallery. From the results shown in Fig.8-18(c), the seismic velocity of the pre-excitation rock mass ranges from 1.6 to 1.8 km/s. From the results shown in Figs.8-18(d) and (e), the layer in which the seismic velocity decreased remarkably (<1.4 km/s) extended approximately 1.0 m in the gallery wall. To investigate

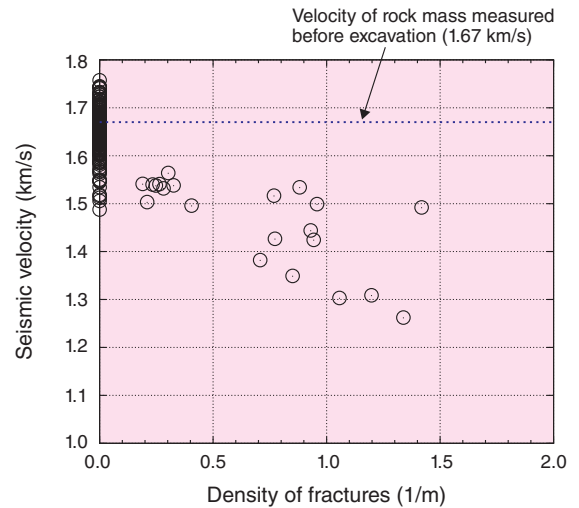
**Fig.8-19 Relationship between seismic velocity and density of fracture**

The circles in the graph represent the relationship between seismic velocity of each ray path and fracture density calculated based on the number of fractures intersected by each ray path.

the mechanism producing the variations in seismic velocity, we obtained the number of fractures intersected by the ray path of a seismic wave based on the result of the fracture mapping of the gallery wall. Next, the fracture density for each ray path was calculated by dividing the number of fractures by the length of each ray path. Fig.8-19 shows the relationship between seismic velocity and fracture density. The figure shows that seismic velocity decreases almost linearly as fracture density increases. Thus, we expect that fracture density around the gallery wall could be estimated from the seismic velocity around the gallery wall. Furthermore, hydraulic tests reveal that enhanced hydraulic conductivity extends approximately 1.2 m into the gallery wall. Consequently, the EDZ in the 250 m gallery is estimated to extend approximately 1.2 m in the gallery wall. In the near future, we will construct a conceptual model of an EDZ based on the results of in situ tests and observations made in the 350 m gallery and in vertical shafts.
