# 1-11 Detection of Defects in the Fuel Cladding Tube

## — Development of a Defect Detection Technique Using High-Resolution X-ray Computed Tomography —

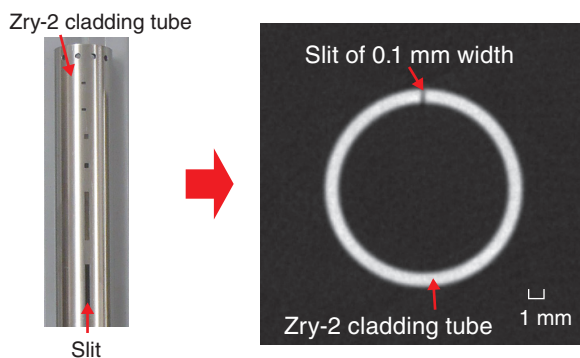
**Fig.1-22 X-ray CT image of a zircalloy-2 cladding tube with a slit**  
A 0.1-mm-wide slit can be observed on the X-ray CT image.

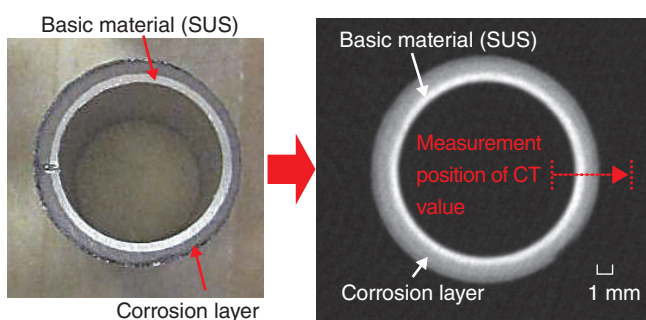
**Fig.1-23 X-ray CT image of a SUS tube with a corrosion layer**  
The corrosion layer could be discriminated from the basic material of a SUS tube.

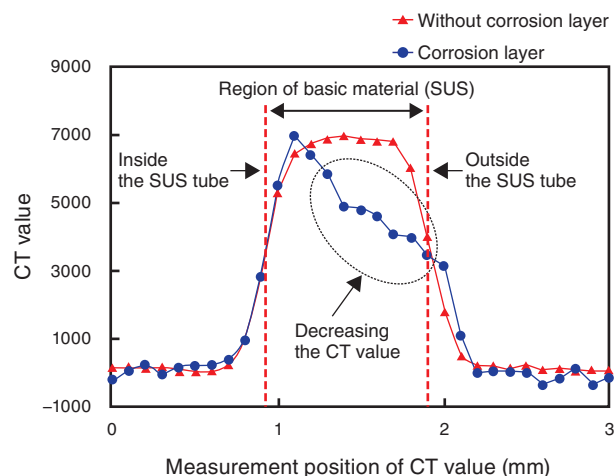
**Fig.1-24 CT value distribution of a SUS tube**  
The CT value decreases with the density. The CT value distribution of the SUS tube with a corrosion layer was lower than that of the SUS tube without the corrosion layer.
