8-7 Investigation of Damage to Rock Mass in Gallery Excavation — Based on Seismic Velocity and Fracture Distribution around Gallery Wall —

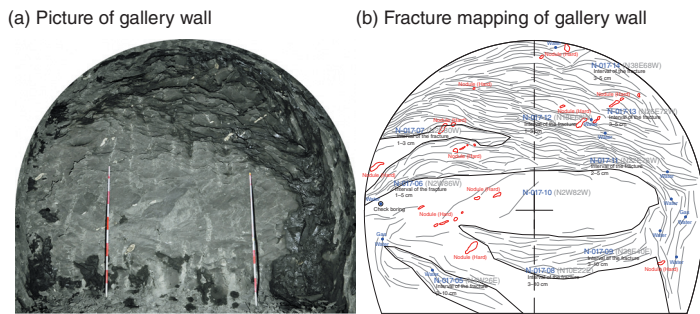
Fig.8-17 Example of fractures induced by gallery excavation
Gray lines in (b) indicate fractures induced by gallery excavation.

In the construction of a deep underground gallery, fractures are induced around the gallery wall because of stress redistribution in response to excavation, as shown in Fig.8-17. In addition, because of these fractures, the hydraulic conductivity of the rock mass increases. Such a zone is called an excavation damaged zone (EDZ). To dispose of high-level radioactive waste, evaluation of an EDZ is important for safety assessment.

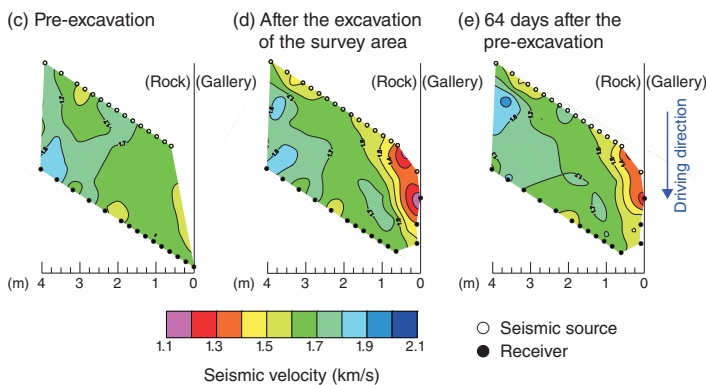
Fig.8-18 Results of seismic tomography survey
Velocity contour map of rock mass around gallery wall.

The Horonobe Underground Research Laboratory is conducting a seismic tomography survey at the depth of each gallery (140 m, 250 m, and 350 m) to investigate the extent of an EDZ. Fig.8-18 shows how seismic velocity changes in response to excavation. These results were obtained from a seismic tomography survey performed in the 250 m gallery. From the results shown in Fig.8-18(c), the seismic velocity of the pre-excitation rock mass ranges from 1.6 to 1.8 km/s. From the results shown in Figs.8-18(d) and (e), the layer in which the seismic velocity decreased remarkably (<1.4 km/s) extended approximately 1.0 m in the gallery wall. To investigate

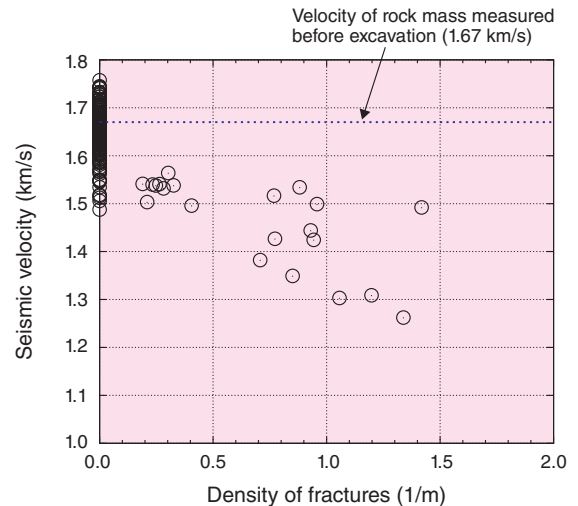
Fig.8-19 Relationship between seismic velocity and density of fracture

The circles in the graph represent the relationship between seismic velocity of each ray path and fracture density calculated based on the number of fractures intersected by each ray path.

the mechanism producing the variations in seismic velocity, we obtained the number of fractures intersected by the ray path of a seismic wave based on the result of the fracture mapping of the gallery wall. Next, the fracture density for each ray path was calculated by dividing the number of fractures by the length of each ray path. Fig.8-19 shows the relationship between seismic velocity and fracture density. The figure shows that seismic velocity decreases almost linearly as fracture density increases. Thus, we expect that fracture density around the gallery wall could be estimated from the seismic velocity around the gallery wall. Furthermore, hydraulic tests reveal that enhanced hydraulic conductivity extends approximately 1.2 m into the gallery wall. Consequently, the EDZ in the 250 m gallery is estimated to extend approximately 1.2 m in the gallery wall. In the near future, we will construct a conceptual model of an EDZ based on the results of in situ tests and observations made in the 350 m gallery and in vertical shafts.
