6-6 Toward Stable and Continuous Hydrogen Production by the IS Process

— Development of a Pump Shaft Seal Technology for HI Solution Including Highly Concentrated I₂ —

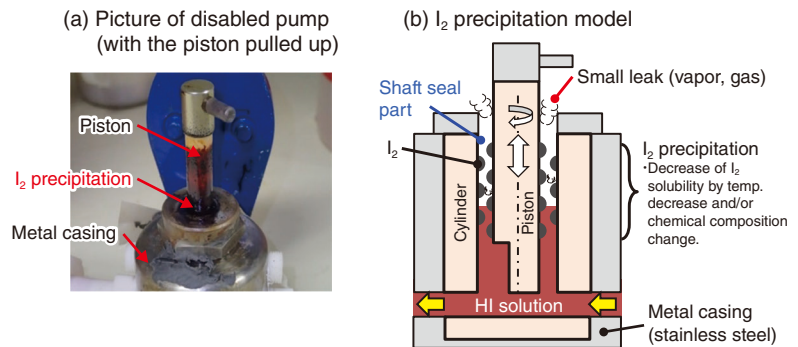
Fig.6-15 Pump malfunction during a hydrogen production test

(a) Solid I₂ was observed on the piston surface of the disabled pump. (b) This malfunction was likely caused by an increasing sliding friction resistance due to a buildup of precipitated I₂ in the narrow gap between the piston and the cylinder owing to the decreased I₂ solubility.

For example, an 8-hour hydrogen production test was performed with a hydrogen production rate of 10 L/h in 2016. However, a pump containing a solution of HI with a high concentration of I₂ was stopped during operation. Solid I₂ was observed on the piston surface of the disabled pump, as shown in Fig.6-15(a). The pump malfunction was likely caused by leakage of process fluid containing I₂ near its solubility limit into the narrow gap between the piston and cylinder, where I₂ was then precipitated due to a decrease in temperature and/or a change in chemical composition. The precipitated I₂ caused an increase in the slide friction, causing the pump to eventually stop (Fig.6-15(b)).

technology was developed by injecting gas and liquid into the narrow gap to flush out solid I₂ (Fig.6-16). This developed shaft seal included four components: ① a heater for preventing I₂ precipitation due to the decrease in temperature, ② an inert gas flow to purge the process fluid and solvent from the gap, ③ the injection of a small amount of solvent (HI solution) to dissolve I₂ that had precipitated in the gap, and ④ vapor suction to remove the leakage from the top side of the pump. The pump equipped with the developed shaft seal technology was then verified under conditions similar to those when the pump stopped functioning. The modified pump worked continuously and stably for 24 h, thus confirming the effectiveness of the developed shaft seal technology. This technology has been applied to the pumps used in the hydrogen production test facility, where hydrogen production was then conducted successfully for 31 hours with a hydrogen production rate of approximately 20 L/h.
