6-6 Toward Stable and Continuous Hydrogen Production by the IS Process

— Development of a Pump Shaft Seal Technology for HI Solution Including Highly Concentrated I₂ —

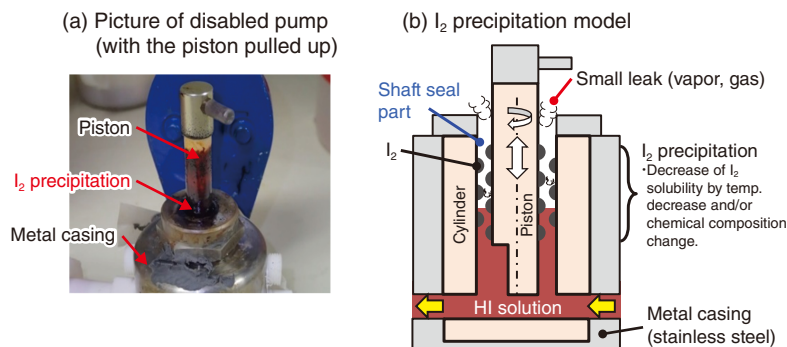
Fig.6-15 Pump malfunction during a hydrogen production test

(a) Solid I₂ was observed on the piston surface of the disabled pump. (b) This malfunction was likely caused by an increasing sliding friction resistance due to a buildup of precipitated I₂ in the narrow gap between the piston and the cylinder owing to the decreased I₂ solubility.

For example, an 8-hour hydrogen production test was performed with a hydrogen production rate of 10 L/h in 2016. However, a pump containing a solution of HI with a high concentration of I₂ was stopped during operation. Solid I₂ was observed on the piston surface of the disabled pump, as shown in Fig.6-15(a). The pump malfunction was likely caused by leakage of process fluid containing I₂ near its solubility limit into the narrow gap between the piston and cylinder, where I₂ was then precipitated due to a decrease in temperature and/or a change in chemical composition. The precipitated I₂ caused an increase in the slide friction, causing the pump to eventually stop (Fig.6-15(b)).

technology was developed by injecting gas and liquid into the narrow gap to flush out solid I₂ (Fig.6-16). This developed shaft seal included four components: ① a heater for preventing I₂ precipitation due to the decrease in temperature, ② an inert gas flow to purge the process fluid and solvent from the gap, ③ the injection of a small amount of solvent (HI solution) to dissolve I₂ that had precipitated in the gap, and ④ vapor suction to remove the leakage from the top side of the pump. The pump equipped with the developed shaft seal technology was then verified under conditions similar to those when the pump stopped functioning. The modified pump worked continuously and stably for 24 h, thus confirming the effectiveness of the developed shaft seal technology. This technology has been applied to the pumps used in the hydrogen production test facility, where hydrogen production was then conducted successfully for 31 hours with a hydrogen production rate of approximately 20 L/h.

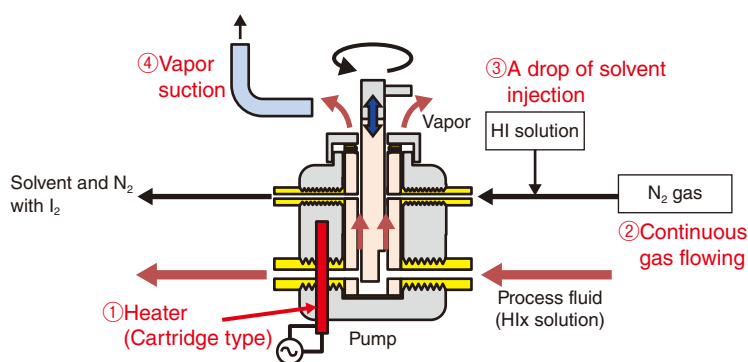
Fig.6-16 Development of shaft seal technology

A shaft seal technology was developed to prevent I₂ precipitation by introducing four elemental technologies; ① a heater for preventing I₂ precipitation, ② an inert gas flow to purge HI and I₂ from the narrow gap, ③ the injection of a small amount of solvent to dissolve I₂, and ④ a vapor suction nozzle to stop the leakage of HI and I₂ vapor.
