1-3 Clarifying the Failure Mechanism of the Lower Part of the RPV

— Melting Test Assuming a Eutectic Reaction in the Complex Structure of a BWR —

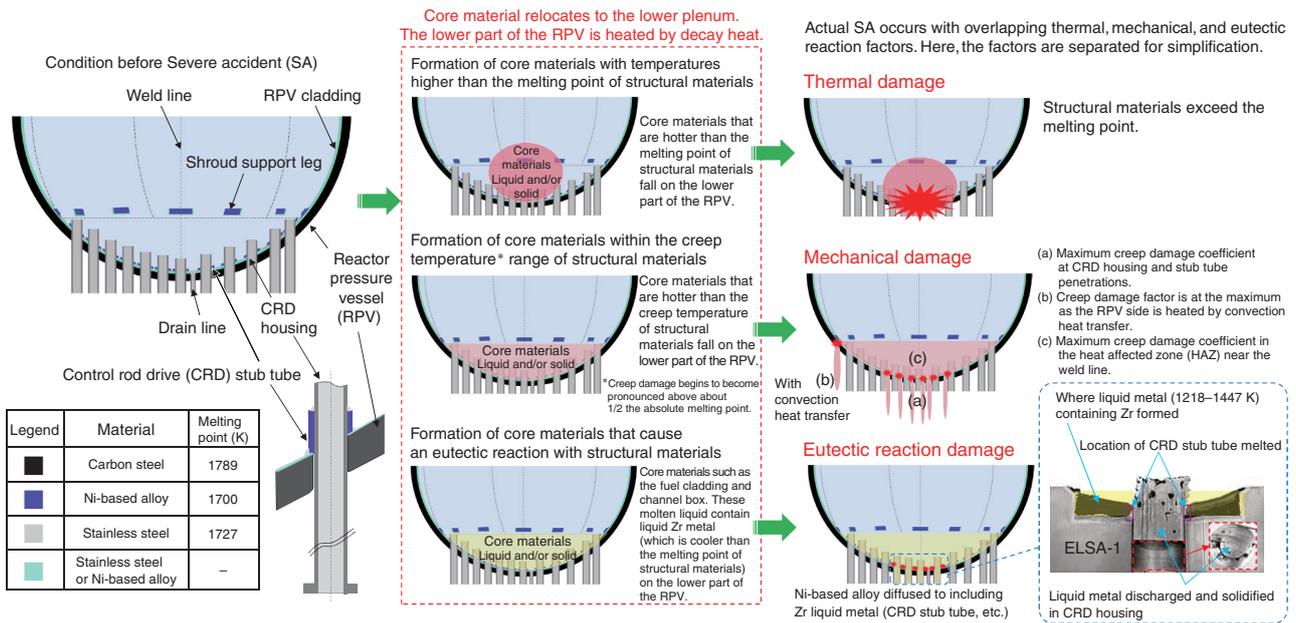
Fig.1-6 Failure mechanism at the lower part of the RPV

The main assumed RPV failure factors are thermal, mechanical, and eutectic reaction damage. To verify the damage caused by the eutectic reaction, ELSA-1 test was conducted. The test results indicated the possibility of molten metal remaining in the CRD housing of the 1F2.

In collaboration with TEPCO, we examined the failure mechanism of the lower part of the RPV (Fig.1-6), taking into account the structure and material composition of the complex substructure specific to a BWR. We evaluated the transition of the core energy during an accident. In 1F Unit 2 (1F2), the core energy increased until the core slumping was small, and the core fuel did not reach the temperature at which it completely melts. It is estimated that most of the core fuel that relocated to the lower plenum was in an unmelted state. In this case, a molten pool was formed at the lower plenum because of the melting of metallic materials such as the fuel cladding, control rod, and channel box.

From the test results, it was verified that depending on the melt pool conditions, the lower part of the RPV can be damaged by eutectic reaction and melting even under conditions in which thermal or creep failure does not occur. The test results indicated the possibility of the molten metal remaining in the CRD housing of 1F2.
