8-5 Decommissioning of a Facility with a History of Contamination Caused by a Fire Disaster in a Controlled Area

— Collective Dismantling of the Uranium Enrichment Laboratory Using a Large Isolation Tent —

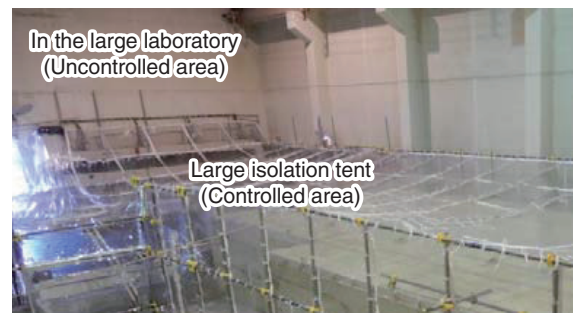
Fig.8-15 Installation of a large isolation tent
To dismantle and remove the rooms, including the controlled areas, that were contaminated by the fire disaster, we installed a large isolation tent to cover these areas.

large isolation tent (Fig.8-15) that covered the entire room was dismantled, and the rooms in the controlled area were carefully demolished. To prevent the scattering of contamination, an adhesive sheet was fixed to the floor surface in the contaminated area, and subsequently, the floor material was peeled off. The concrete surface where the contamination remained was removed by installing a partial isolation tent at each work site and using a power tool with a dust collecting function.

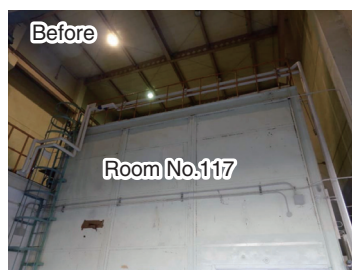
Dismantlement of
room No.117

Fig.8-16 Overview of the large laboratory before and after decommissioning

The photographs provide an overview from the vicinity of the shutter in the northeast of the large laboratory and compare the space before and after the dismantling. After the controlled area was released, it was used as a general facility.

The work toward the decommissioning of the Uranium Enrichment Laboratory was conducted based on safety considerations, such as contamination spread prevention measures and fire prevention measures, and the controlled area was released without any disaster in FY2019 as planned (Fig.8-16). The building after releasing the controlled area is being used as a general facility. We believe that the knowledge gained from the decommissioning of this facility will be useful for the safe decommissioning of facilities that are difficult to decontaminate because of the remaining contamination.
