10-2 Toward the Practical Application of Flame-Retardant Waste Treatment Test Equipment — Selection of Repair Materials for the Main Reactor Refractory —

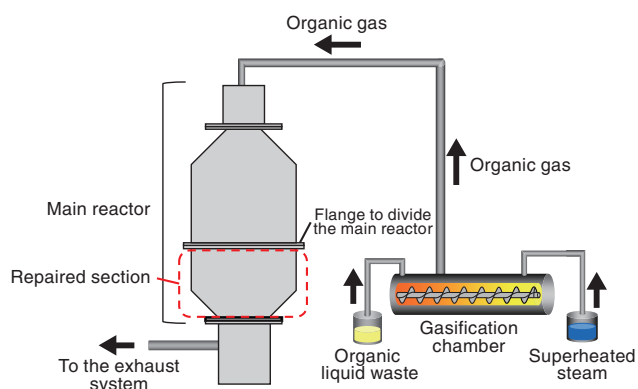
Fig.1 Diagram of the main reactor and repaired section
The main reactor can be divided into upper and lower sections and contains refractory material (15 cm thick).

Fig.1 shows a diagram of the steam reforming treatment system. The main reactor, which burns organic gases, shows cracks and flaking of the refractory caused by age-related deterioration, and hence, it requires repairs. To select the appropriate repair material, two materials—plastic refractory and phosphate refractory—were evaluated. These materials have the same composition and thermal properties as the main reactor refractory. The plastic and phosphate refractory materials were applied to areas (A) and (B) of the main reactor, respectively, as shown in Fig.2. To determine the typical tensile strength and hardness values of the repair materials, some test pieces comprising 1-cm-thick cylindrical repair materials were attached to area (C). After applying the repair materials, a heat treatment process was conducted for sintering the repair materials for 4 h at a maximum temperature of 1200 °C inside the main reactor; these conditions are identical to those in an actual steam reforming treatment process.

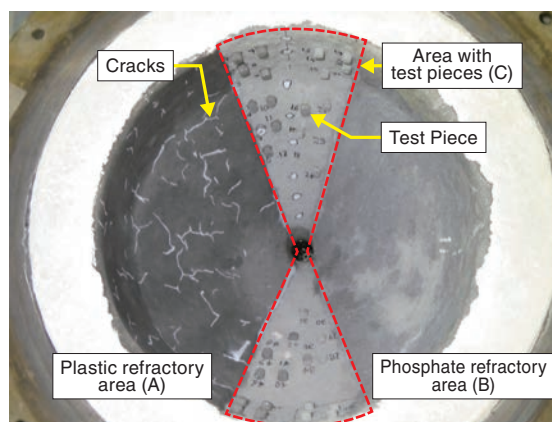
Fig.2 Overhead view of the repaired area after the repair and treatment process

Repair materials were applied to areas (A) and (B), and test pieces were attached to area (C).

The visual inspection after the treatment showed that the plastic refractory area (A) had cracks and flaking throughout, while the phosphate refractory area (B) had only a few small cracks on the surface of the repair material, as shown in Fig.2. This indicates that the plastic refractory repair method is inappropriate and that the phosphate refractory repair method is effective for repairing the main reactor refractory.

The tensile strength is the vertical force required to detach a test piece. The tensile strength was 0.9 N/mm² for the plastic refractory and 0.45 N/mm² for the phosphate refractory. These values exceed the general construction standard of tensile strength of 0.4 N/mm². Thus, the adhesion of each repair material is satisfactory.
