## 4-10 Inspection and Repairing Welding System for an Inner Tube Wall — Combination Laser Processing Technique and Eddy Current Testing —

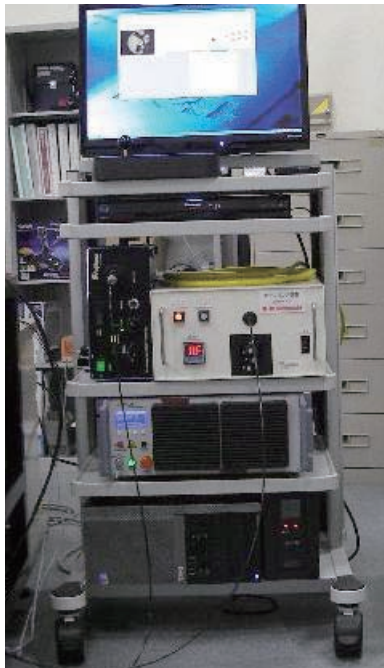
**Fig.4-19 Control system**  
The control system was stowed in a small portable rack.

Fig.4-19 shows the appearance of the control system stowed in a small portable rack. The backbone of the probing system consists of a composite-type optical fiberscope which has a unique coaxial design. The fiberscope can deliver a high energy laser beam for welding along the center fiber, which is surrounded by thousands of image fibers. A laser processing head is connected at the end of the fiberscope, which is shown in Fig. 4-20. The laser processing head can attain 360 degree round-trip scanning of the inner wall of heat

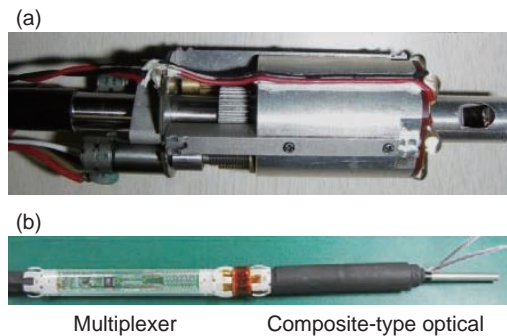
**Fig.4-20**

**(a) Laser processing head**

The laser processing head with a composite-type optical fiber scope can inspect 1-inch diameter heat exchanger tubes and repair cracks by laser welding.

**(b) ECT coil sensor**

The Eddy Current Testing (ECT) coil sensor mounted on a composite-type optical fiber cable can detect cracks on the inside wall of the 1-inch diameter heat exchanger tubes.

exchanger tubes with fine adjustment for the laser irradiation position. Just beside the laser processing head, an ECT multi-coil sensor is mounted on a composite-type optical fiber cable, which is shown in Fig.4-20. In addition, a CCD camera for image capture and a temperature monitor recorder for key optical components are included. In order to complete the system, a high energy ytterbium fiber laser is integrated into the control system rack as a tightly focused welding heat source.

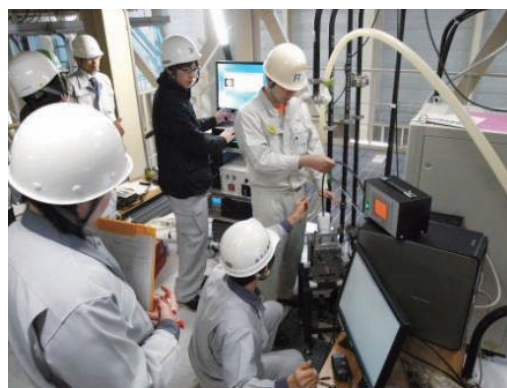
**Fig.4-21 Demonstration of heat exchanger tube inspection and repair**

The mock-up facility at Shiraki in Tsuruga city was used for the demonstration. The performance of the prototype was confirmed in a maintenance drill.

To confirm the performance of the system, a maintenance demonstration for 1-inch diameter heat exchanger tubes was carried out in the mock-up facility of the Monju steam generator heat exchanger unit. Fig.4-21 shows the demonstration where both ECT inspection and laser welding repair for cracks in 1-inch heat exchanger tubes were carried out. This system can grant us new possibilities for wall maintenance in complex piping facilities such as chemical plants or steam boilers as well as atomic power stations. We will apply this technology to decontamination of scaling deposited on the inner wall of piping.
