7-1 Demonstration of the In-Vessel Repair Technology within the Fast Reactor “JOYO” — Replacement of a Large Structure and Retrieval of a Deformed Test Subassembly —

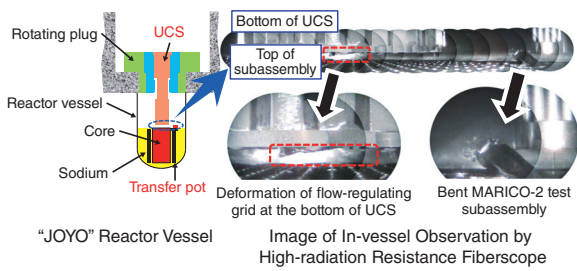
Fig.7-2 Occurrence of an obstacle in the reactor vessel
In the “JOYO” reactor vessel, the lower part of the upper core structure was damaged and the MARICO-2 test subassembly was bent and extruded from a transfer pot. In the area where the UCS makes contact with the MARICO-2 test subassembly, the operation of a rotating plug (UCS was installed in the rotating plug) for fuel-exchange work had to be restricted.

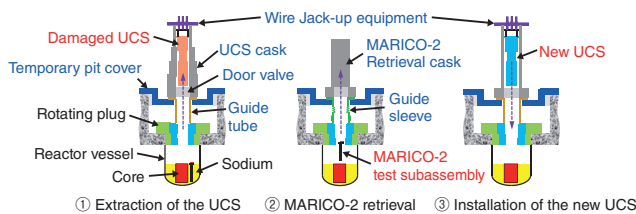
Fig.7-3 Flow of the UCS replacement and MARICO-2 test subassembly retrieval work

The first step is the extraction of the damaged UCS. The second step is retrieving the MARICO-2 test subassembly from the UCS removal hole. The final step is the installation of a new UCS. These objects, which have very high surface dose rates above 100 Sv/h, were handled in this work.

The restoration work was conducted as shown in Fig.7-3. “JOYO” is a sodium-cooled fast reactor (SFR) in service, and hence, the equipment used for the task had to be capable of withstanding high temperatures (sodium temperature is around 200 °C) and high doses of radiation (components are highly radioactive due to high neutron flux) and it was required to maintain the argon cover gas boundary. Various techniques were developed throughout the study, and the following are introduced as representative examples: (1) UCS jack-up equipment for replacement and (2) MARICO-2 test subassembly retrieval device. In the process of development, mock-up tests were conducted to confirm the functions of the equipment and device in the manufacturer’s factory. The data and knowledge obtained by the tests supported the implementation of various techniques and operation methods.

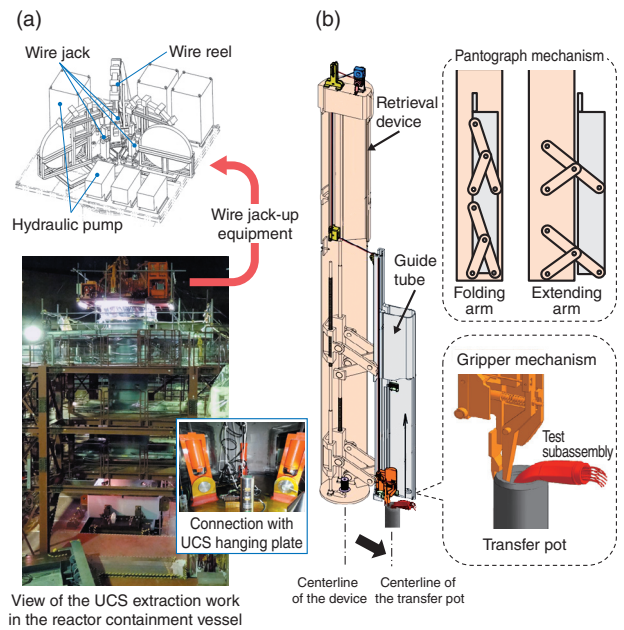
Fig.7-4 An example of a result of technological development
Jack-up equipment for replacement of the UCS and the MARICO-2 test subassembly retrieval device must be able to handle the damaged components by remote operation. This technology has been accumulated and practiced for a long time in the history of “JOYO” and is reflected in the development and operation of the equipment.

check the levelness of the UCS and the applied load to avoid mechanical interference with the surrounding structure and to detect contact and load abnormality quickly on the assumption that there is not much clearance. Furthermore, the state of the UCS could not be observed visually because the UCS with a high dose had to be jacked-up into a large, thick iron cask, as shown in Fig.7-4(a). Hence, this equipment has a stop system interlocked with the load monitoring.

(2) The MARICO-2 test subassembly retrieval device was installed in a removal hole for the UCS. The location of a gripper is adjusted by a remotely operated pantograph mechanism, as shown in Fig.7-4(b). The MARICO-2 test subassembly is gripped and lifted up with the transfer pot by the retrieval device. In the design of this device, temperature-resistant materials were selected and the change in size of this long mechanism due to thermal expansion was carefully considered. Moreover, multiple countermeasures were taken to prevent accidental fall of the transfer pot in the retrieval operation.
