8-1 Lessons Learned from the Chernobyl Nuclear Power Plant — What is the Condition Needed to Suppress Degradation of Fuel Debris? —

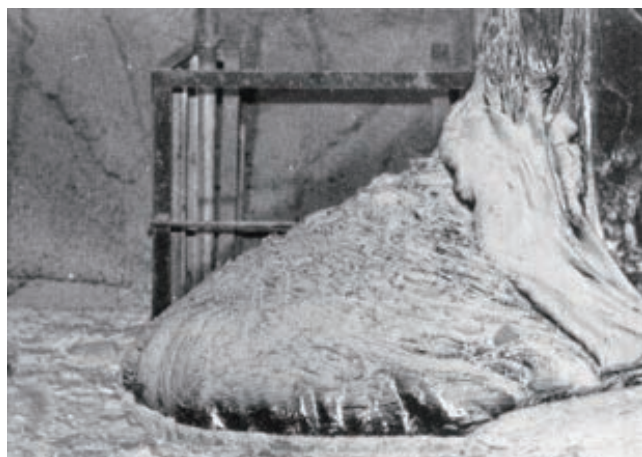
Fig.1 “Elephant foot” observed immediately after the accident*1
Fuel debris shaped like an elephant's foot was formed during the Chernobyl NPP accident that occurred in 1986. It was very hard, glassy, black, lava-like materials with very high radioactivity and a large amount of concrete components.

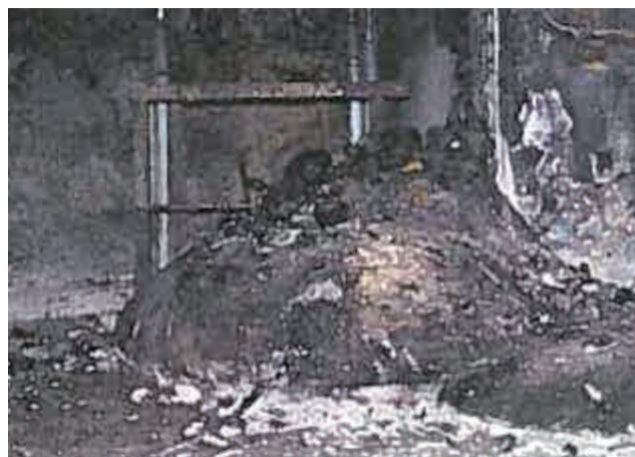
Fig.2 “Elephant foot” about 10 years after the accident*2
After approximately 10 years, the elephant foot shown in Fig.1 was confirmed to have started crumbling because of aging, and some of it was scattered as fine radioactive particles.

The physical aging of fuel debris in ChNPP-4 is attributed to seasonal and daily temperature changes, airflow caused by pressure differences inside the building, and due to self-irradiation of radiation due to α -decay, but these effects are considered to be relatively small. Next, chemical aging is mainly attributed to reaction with water that has become more reactive due to radiation, and precipitates containing uranium as the main component have been confirmed. These precipitates are regarded to have actually been formed by reaction with moisture. In addition, many microorganisms such as fungi have been confirmed in the building, and the effects of biological aging
