6-6 Toward Stable and Continuous Hydrogen Production by the IS Process

— Development of a Pump Shaft Seal Technology for HI Solution Including Highly Concentrated I₂ —

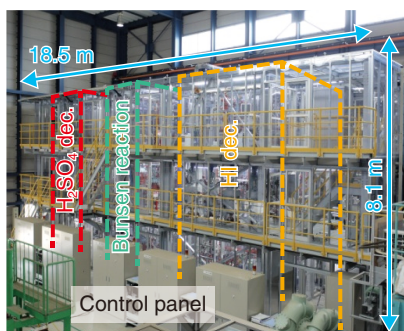
Fig.6-14 External view of hydrogen production test facility

This facility is being used for the demonstration of hydrogen production via the IS process toward the practical application of the IS process.
