8-5 Decommissioning of a Facility with a History of Contamination Caused by a Fire Disaster in a Controlled Area

— Collective Dismantling of the Uranium Enrichment Laboratory Using a Large Isolation Tent —

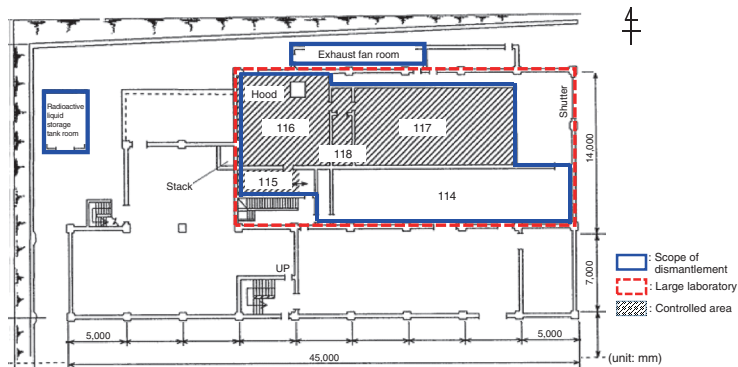
Fig.8-14 Floor plan of the first floor of the Uranium Enrichment Laboratory
At the time of the decommissioning, in the Uranium Enrichment Laboratory, a part of a steel-framed room was installed in the large laboratory as a controlled area. In addition, this controlled area was equipped with exhaust and drainage facilities.
