5-4 Is Safety Maintained in Loss-Of-Coolant Accident even with Long-Term-Used Fuel? — Evaluation of Light Water Reactor Fuel Behavior under LOCA Conditions —

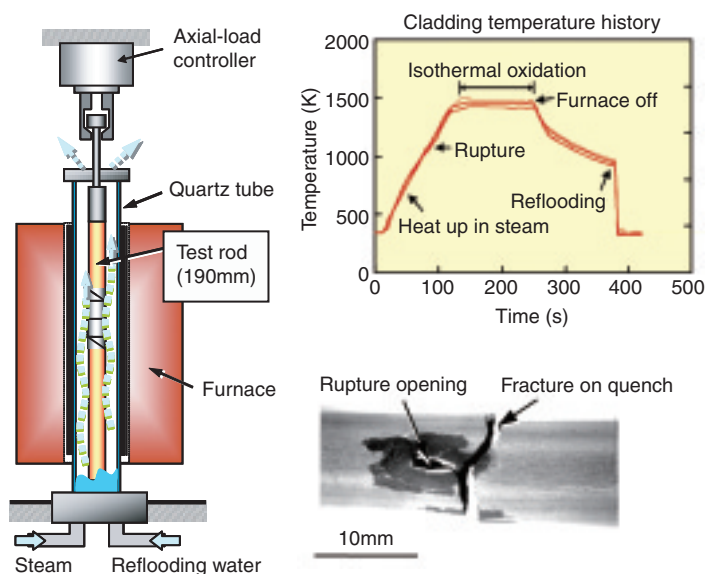
Fig.5-7 LOCA-simulated experiment

Test rod is heated to 1200 – 1500 K in flowing steam with the furnace. After isothermal oxidation, the test rod is cooled and quenched with flooding water. The photograph shows post-test appearance of irradiated fuel cladding.

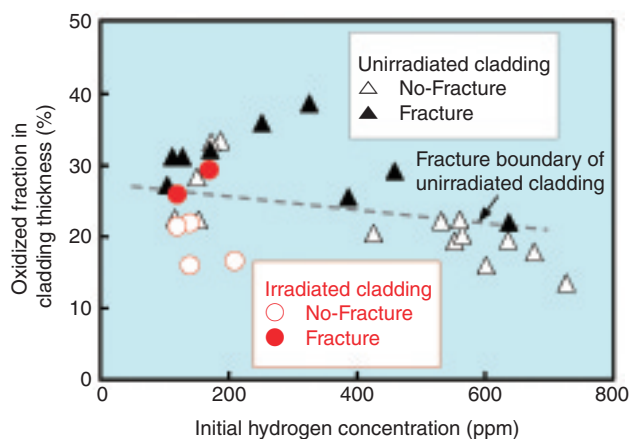
Fig.5-8 Fracture map, relevant to oxidized fraction and initial hydrogen concentration

Results with unirradiated cladding (triangles) show that fracture preliminary depends on oxidized fraction and slightly on hydrogen concentration. Results with irradiated cladding (circles) show that fracture boundary is not reduced significantly by irradiation at the examined burnup level.

In a postulated loss-of-coolant accident (LOCA), fuel temperature is increased for several minutes until the emergency core cooling system (ECCS) recovers the coolability of the reactor core. Fuel cladding, composed of zirconium-based alloys, becomes brittle if it is severely oxidized during the high-temperature period, and may fracture by thermal shock during the emergency core cooling. Heat removal may not be possible in the case that fragments from the fractured fuel accumulate in the lower part of the reactor core. To maintain coolable geometry of the reactor core, the Japanese LOCA criteria require that the peak clad temperature shall not exceed 1473 K (1200°C), and the oxidized fraction shall not exceed 15% of the cladding thickness. The 15% criterion is based on fracture/no-fracture

boundary conditions determined by laboratory-scale experiments simulating LOCA conditions. Since most of the previous experiments used only unirradiated cladding, information regarding irradiated cladding was insufficient. Hence, we devised a simulating apparatus (Fig.5-7) in a hot-cell and performed the LOCA-simulating experiments with cladding that had been irradiated for a long term (burnup: 39 to 44 GWd/t) in a commercial pressurized water reactor (PWR). As a result, important information was obtained on overall behavior and fracture conditions of irradiated cladding under LOCA conditions. Fig.5-8 shows that fracture conditions of the irradiated cladding are identical to those of unirradiated cladding which has been equivalently pre-hydrated simulating hydrogen absorption that occurs during reactor irradiation. Accordingly, the fuel safety in a LOCA is not degraded by long-term irradiation of the examined range, though the fracture boundary oxidation value is reduced by hydrogen absorption to some extent. The obtained information is used in the regulatory judgment by the government.
