5-3 Degradation of Cladding Ductility Affected by Cooling History

— Effect of Cooling History on Cladding Ductility under LOCA Conditions —

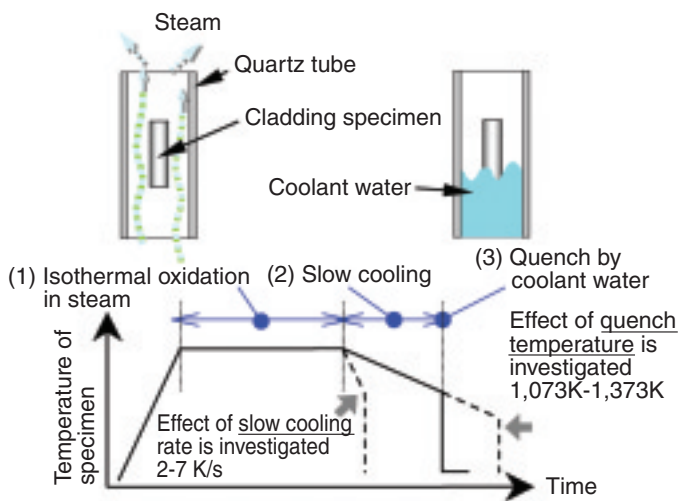
Fig.5-7 Oxidation and quench test to simulate LOCA conditions

Steam is supplied into the quartz tube and the cladding specimen is heated to 1,373K. After isothermal oxidation, steam supply is stopped and the specimen temperature is slowly lowered (slow cooling). Finally, coolant water is supplied to quench the specimen. These tests were conducted with different rates of slow cooling and quench temperatures. The oxidized specimens were subjected to the ring-compression test, in which a specimen was compressed in its radial direction, to investigate their ductility.

In the present study, cladding specimens were oxidized in steam at high temperatures, cooled slowly, and quenched by water flooding (Fig.5-7). These tests were conducted with different rates of slow cooling and quench temperatures in order to investigate their effects on the post quench ductility of the cladding. As a result, it was found that the post-quench ductility decreased with decrease in the quench temperature as shown in Fig.5-8. On the other hand, the effect of the slow cooling rate was negligible. In the metallurgical examination after oxidation (Fig.5-8), the area of the α phase region, which appeared to be a white agglomerate, was large in the embrittled cladding specimens. The α phase region is oxygen-rich, hard, and brittle compared to the matrix region around the agglomerates. The ductility reduction with the quench temperature decrease can be attributed to the relative increase in the area of α -phase regions, which can be a preferential path for crack propagation.

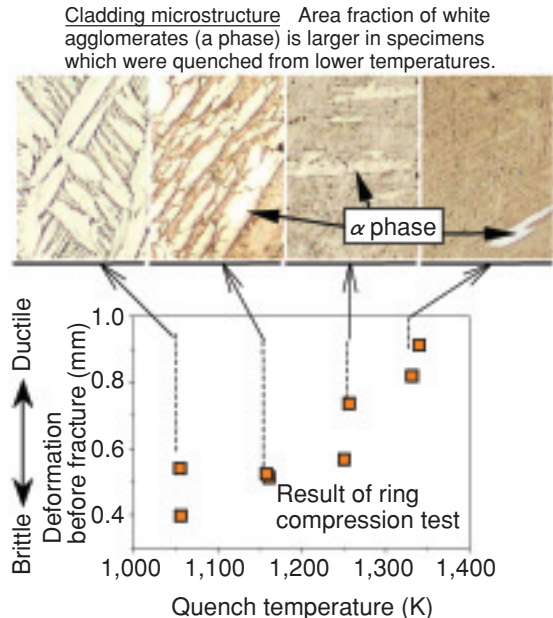
Fig.5-8 Correlation between quench temperature and cladding ductility

Ductility change of cladding specimens with different quench temperature was investigated. The ductility decreases with decrease in the quench temperature.
