3-3 Long-Term Investigation of an Excavation Damaged Zone around a Gallery — Seismic Tomography Survey for Investigation of an EDZ —

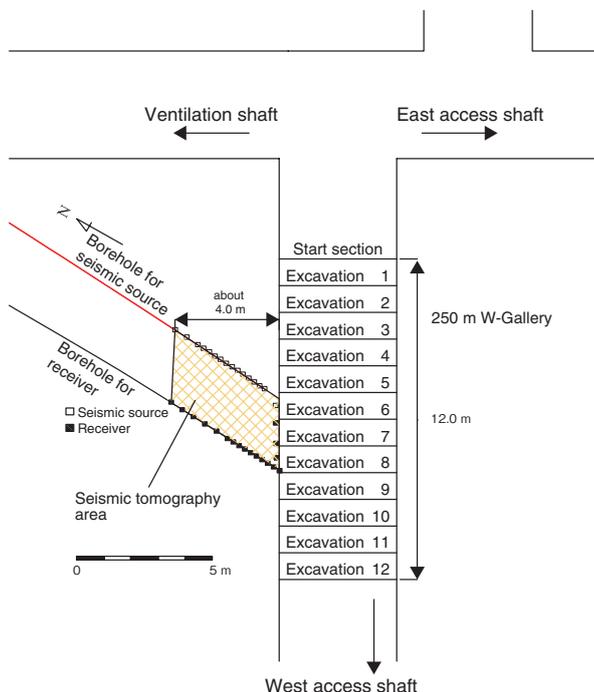
Fig.3-10 Layout of the seismic tomography

This figure shows a plan view of the 250 m gallery off the west shaft (250 m W-Gallery).

Fig.3-10 shows a plan view of the layout of the seismic tomography in a gallery at a depth of 250 m. Seismic tomography was conducted at the 250 m W-Gallery during

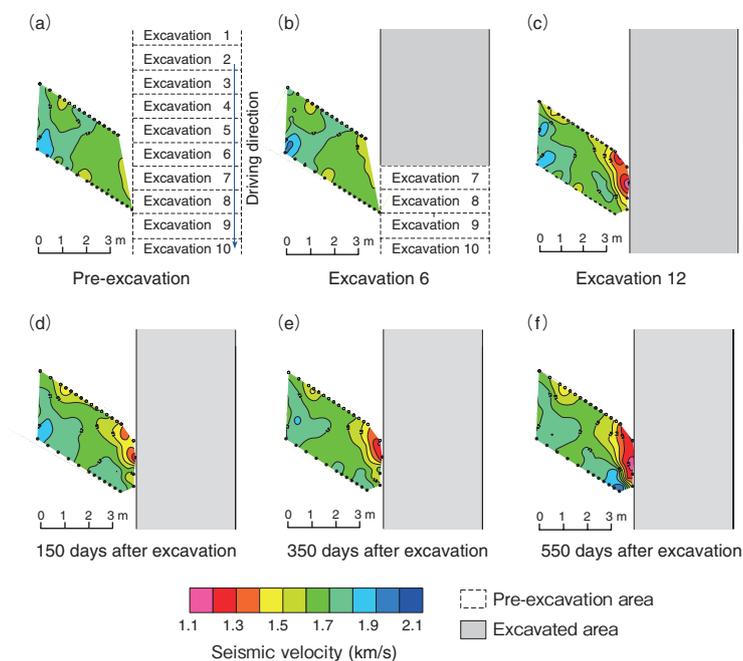
Fig.3-11 Results of seismic tomography survey

These figures show the velocity contour maps at each investigation stage.

excavation (Excavations 1 to 12) and after the excavation of the gallery was complete. Fig.3-11 shows the results of the seismic tomography survey. In the pre-excavation and Excavation 6 stages, shown in figures (a) and (b), the seismic velocity did not change remarkably. In Excavation 12, shown in figure (c), a low-velocity area in which the velocity decreased to around 1.3 km/s developed about 1.0 m into the gallery wall. After the gallery was completely excavated, the low-velocity area was smaller at 150 days after excavation, as shown in figure (d), but had expanded again at 350 and 550 days after excavation, as shown in figures (e) and (f), respectively. Consequently, it was found that the EDZ can be expected to develop about 1.0 m into the gallery wall and that the extent of the low-velocity area changes with time.
