1-11 Detection of Defects in the Fuel Cladding Tube

- Development of a Defect Detection Technique Using High-Resolution X-ray Computed Tomography -

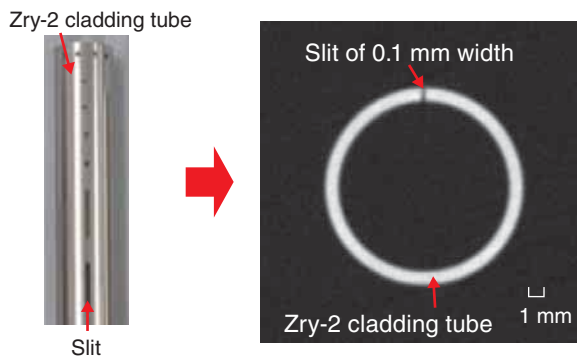
Fig.1-22 X-ray CT image of a zircalloy-2 cladding tube with a slit

A 0.1-mm-wide slit can be observed on the X-ray CT image.

addition, SUS tube specimens having corrosion layers were manufactured and also subjected to X-ray CT examination to obtain basic data about detection performance on the corrosion layer. The 0.1-mm-wide slit on the Zry-2 cladding tube could be observed on the X-ray CT image in Fig.1-22, and a corrosion layer (gray region) with a thickness of more than 0.35 mm could be discriminated from the basic material (white region) in the X-ray CT image in Fig.1-23. An X-ray CT examination of the Zry-2 cladding tube based on this result has been conducted.

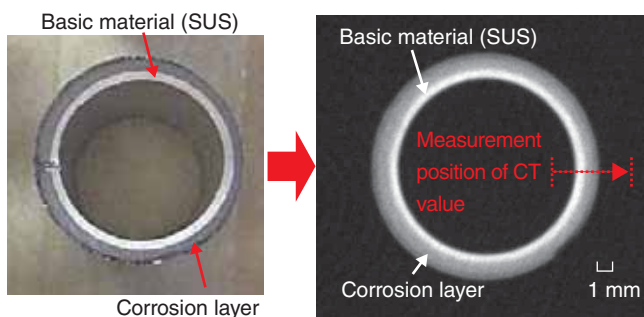
Fig.1-23 X-ray CT image of a SUS tube with a corrosion layer

The corrosion layer could be discriminated from the basic material of a SUS tube.

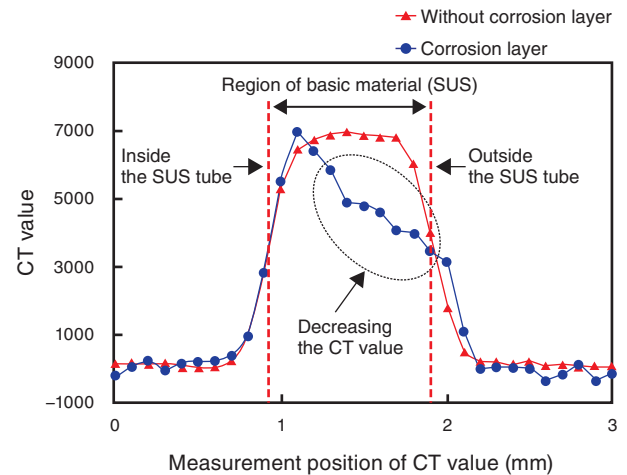
Fig.1-24 CT value distribution of a SUS tube

The CT value decreases with the density. The CT value distribution of the SUS tube with a corrosion layer was lower than that of the SUS tube without the corrosion layer.

The X-ray CT image is composed of CT values, which depended upon the density. This image analysis technique was developed to evaluate the slit width and the corrosion thickness using the CT value distribution (Fig.1-24). The defect on the fuel cladding tube can be evaluated without dismantling of the fuel assembly by using this image analysis technique. At present, a high performance image analysis technique is being developed to increase the evaluation accuracy.
