## 2-1 Investigation of the Fracture Resistance of Zircaloy Cladding under a Post-LOCA Condition — Evaluation of Ruptured and Quenched Cladding by Four-Point-Bend Tests —

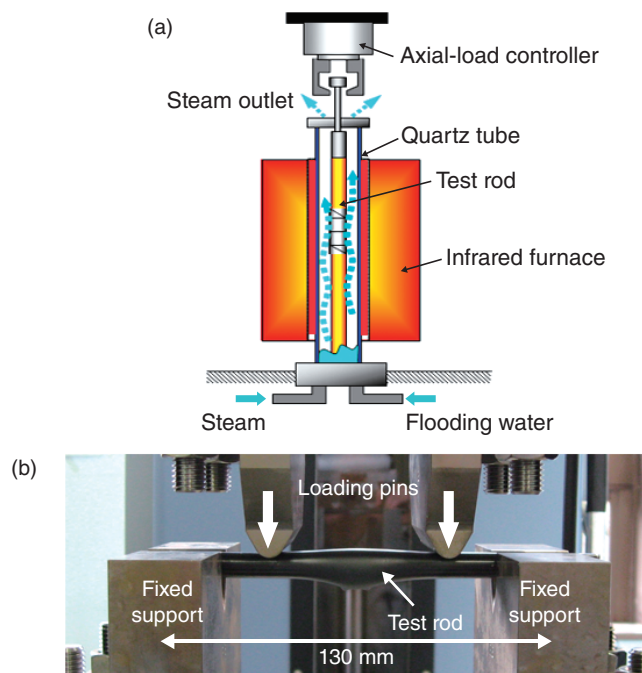
**Fig.2-3 (a) Schematic of oxidation and quench test used to simulate a LOCA condition**

**(b) Ruptured cladding specimen mounted in a four-point-bend test jig**

(a) A test rod is heated in the furnace in steam flow. During the heat-up phase, the cladding balloons and ruptures due to rod-inner-pressure increase and cladding strength deterioration. After the isothermal oxidation phase, the test rod is quenched by water injected from the bottom.

(b) A four-point-bend test apparatus is designed to apply a uniform bending moment to the rupture region and to generate tensile stress on the rupture side.

A four-point-bend test apparatus (Fig.2-3(b)) is designed to evaluate the fracture-resistance of the cladding that is tested under simulated LOCA conditions.
