8-3 Understanding the Self-Sealing Function of the Underground Environment

— Study of the Long-Term Behavior of Hydrogeological Structures Related to Faulting —

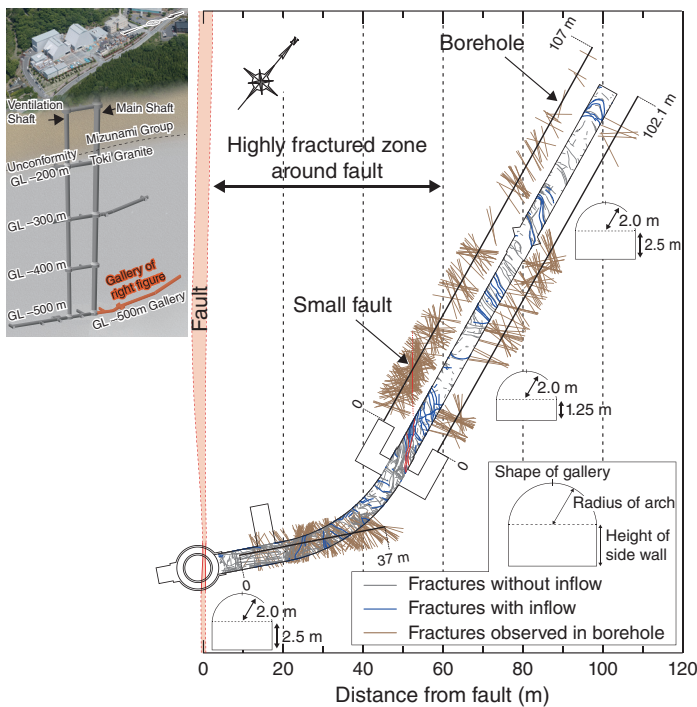
Fig.8-9 Fracture distribution at the GL -500 m gallery and layout of the Mizunami Underground Research Laboratory
Fractures with groundwater inflow comprise approximately 10% of all known fractures (146 of 2002 fractures) at the GL -500 m level. A highly fractured zone extends approximately 60 m from the fault.

Understanding long-term groundwater flow is critical to assess the safety of geological disposal of high-level radioactive waste (HLW). Fractures in crystalline rock, such as granite, function as pathways for groundwater flow. Characteristics of fractures have the potential to change due to faulting and/or formation of fracture fillings. The dynamic behavior of hydrogeological structures around faults has therefore been studied at 500 m below ground level (GL) in the Mizunami Underground Research Laboratory (Fig.8-9).

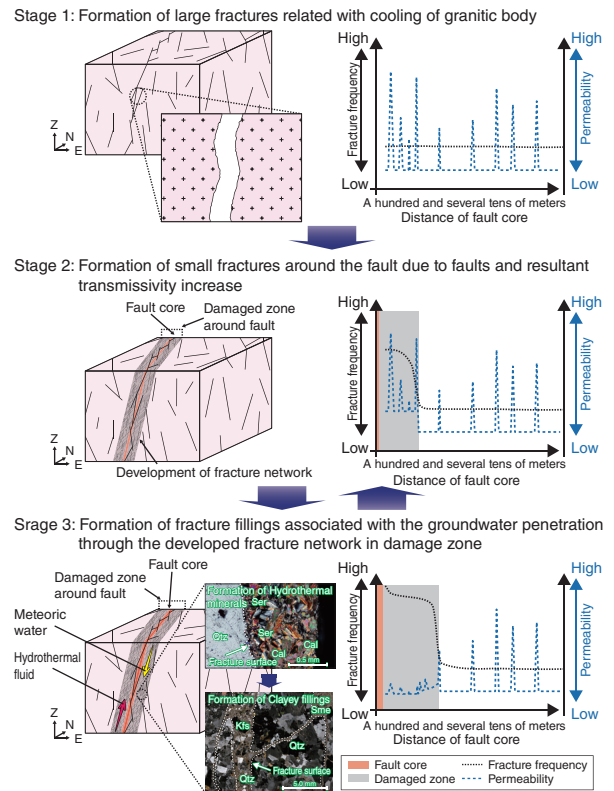
Fig.8-10 Long-term behavior of hydrogeological structures around faults

The permeability of the damage zone is increased by faulting but decreased by precipitating and injecting minerals to close and/or seal fractures by penetration of reactive groundwater and fault reactivation.

Detailed borehole and gallery-wall investigations indicate that there are three stages in the development of hydrogeological structures (Fig.8-10). The first stage is characterized by the formation of relatively large primary fractures after the temperature of the granite pluton has decreased through the ductile-brittle transition and is subjected to brittle-deformation conditions. Collectively, these primary fractures act as the primary pathway for groundwater. The second stage is associated with faulting of the pluton and formation of a damage zone containing relatively small fractures, which act to increase

the hydraulic permeability. The third stage is marked by a decrease in the hydraulic permeability of the damage zone caused by the precipitation of secondary minerals, typically including sericite, chlorite, and calcite, from the infiltration of reactive groundwater. As much as 90% of fractures can be sealed in this manner. Additionally, unconsolidated clayey fillings, which are formed by injected under high-pressure pore water associate with fault reactivation, can act as a natural grout material. These fillings are a unique feature of active orogenic fields found in the Japanese islands.
