6-6 Reliability Improvements of Corrosion-Resistant Equipment for Hydrogen Production by the IS Process — Refined Quality Management of Glass-Lined Steel Material —

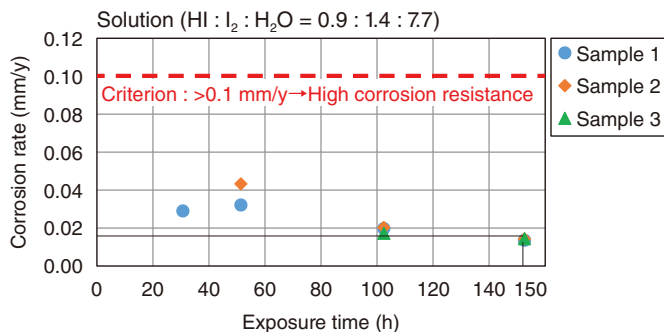
Fig.6-12 Corrosion rate of glass-lined steel in a hydroiodic acid and iodine solution

The corrosion rate was determined by weighing the specimen before and after testing. The corrosion rate after 150 h of exposure was 0.02 mm/y, lower than the criterion of excellent corrosion resistance (0.1 mm/y).

Corrosion rates were determined by weighing the test specimens before and after exposure to the hydroiodic acid and iodine solution. The solution was heated to approximately 115 °C under atmospheric pressure. The corrosion rate was approximately 0.02 mm/y after 150 h exposure, significantly

lower than the criterion of excellent corrosion resistance (0.1 mm/y), as shown in Fig.6-12.

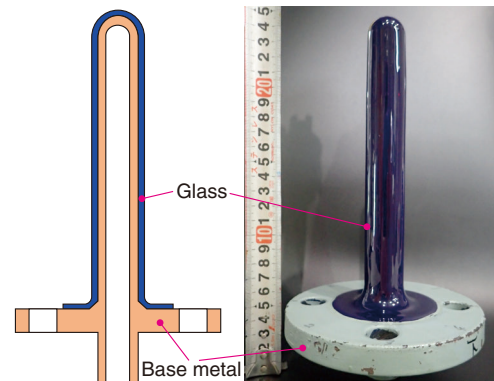
Fig.6-13 Prototype of the glass-lined thermocouple protective sheath

Based on the refined quality management, the glass-lined thermocouple protective sheath was prototyped; the prototype was thick enough and contained no inner bubbles, contamination, or pinholes.

Additionally, defects causing breakage of the lined glass in manufacturing process were revealed, including cracks, inner bubbles, foreign substance contamination, insufficient glass thickness, and generation of pinholes. To eliminate these defects, quality management was refined by performing detailed visual observations at each manufacturing step, measuring the glass thickness after glass lining, and performing high-voltage inspection to find pinholes. From this basis, glass-lined thermocouple protective sheaths were made and subjected to heat cycle and bending load testing (Fig.6-13). No breakage occurred on the lined glass after performing 10 heat cycles from room temperature to 180 °C, nor after excessive bending load up to 150 kgf on the top of the sheath (Fig.6-14).

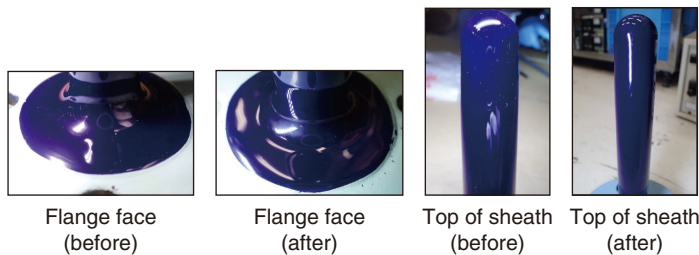
Fig.6-14 External appearance of the prototype after the heat cycle test

No breakage was seen on the lined glass after cycling from room temperature to 180 °C 10 times.
