8-12 Investigation of Fuel-Cladding Materials for the Reprocessing of Spent Nuclear Fuel

— Evaluation of the Nitric Acid Resistance of New Materials Preventing Severe-Accident Progression —

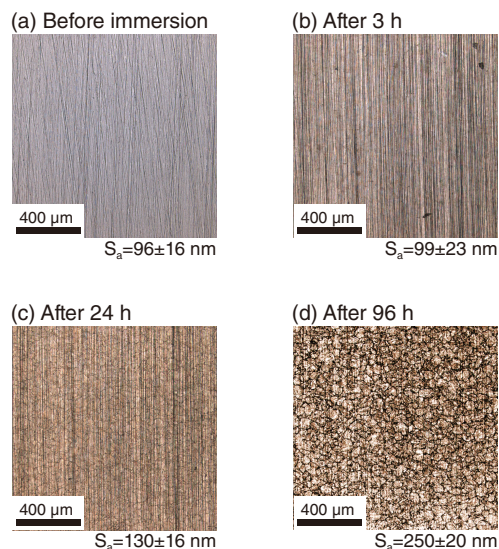
Fig.8-30 Specimen surface before and after immersion in a boiling nitric acid solution

The surface of the specimen was observed by laser microscope. Corrosion marks were observed on the surface after 96 h of immersion. The surface roughness, evaluated by the arithmetical mean height of the surface (S_a), increased with the immersion time, indicating the progress of corrosion.

The behavior of elements on the top surface of the FeCrAl-ODS steel specimen shown in Fig.8-30(d) was investigated via X-ray photoelectron spectroscopy (XPS). The results indicated that an oxide film was generated on the top surface and iron (Fe) was selectively dissolved from the oxide film. Chromium (Cr) and aluminum (Al) remained as oxides on the top surface.

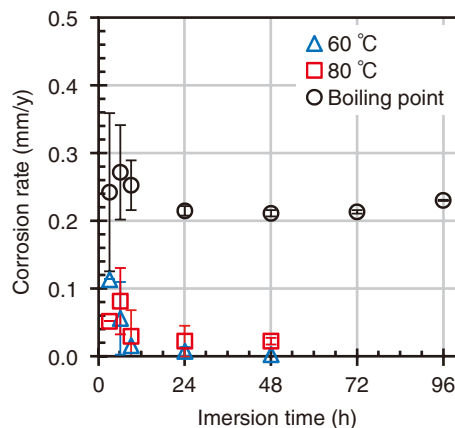
Fig.8-31 Corrosion rates of the FeCrAl-ODS steel in 3 mol/dm³ nitric acid solution at different temperatures

The corrosion rate (mm/y), which was calculated by mass loss (g), at the boiling point was higher than that at 60 °C and 80 °C, where it decreased to approximately 0.22 mm/y with increased immersion time.

As in the fuel dissolution process, simulated fuel cladding specimens were immersed into a high-temperature solution with a high concentration of nitric acid (3 mol/dm³, as is the operational concentration in the dissolver). After several hours of immersion, the specimen was weighed and its surface was observed. The resulting variation of the specimen surface in the immersion experiment is shown in Figs.8-30(a)–(d). After 3 h of immersion, no clear sign of corrosion was observed, indicating a favorable corrosion resistance of FeCrAl-ODS steel. The resulting corrosion rate is shown in Fig.8-31, indicating that

FeCrAl-ODS steel has a better corrosion resistance than does stainless steels utilized for component of reprocessing process.
