8-6 Change in Permeability after Backfilling a Research Tunnel — Change in Hydraulic Conductivity in the Simulated Realistic Disposal Environment —

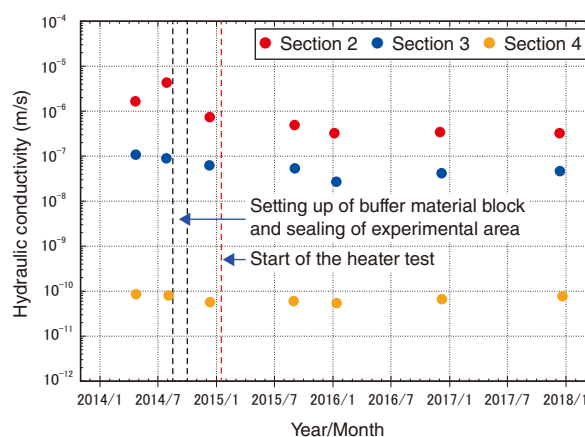
Fig.8-15 Simulated hydraulic conductivity

In Sections 2 and 3, the hydraulic conductivity slightly decreased from January 2014 to January 2016, but then remained constant.

The EDZ hydraulic conductivity in Sections 2 and 3 after the excavation of the test pit was $1.7\text{--}4.3 \times 10^{-6}$ and 8.9×10^{-8} to 1.1×10^{-7} m/s, respectively, representing values 3–5 orders of magnitude higher than those in the unfractured zone ($8.0\text{--}8.6 \times 10^{-11}$ m/s), as shown in Fig.8-15. In Sections 2 and 3, the hydraulic conductivity decreased by approximately one order of magnitude with time for the first two years, but then remained constant from January 2016. This suggests that the aperture of the EDZ fracture was not changed significantly, although the swelling of the buffer material did cause compression stress around the test pit. Therefore, these results provide fundamental data that will be instrumental in developing a model to predict the hydraulic conductivity of the EDZ.
