2-3 Effects of Stress on Oxidation near a Crack Tip

— Toward an Understanding of the Mechanism of Environmentally-Assisted Cracking in Stainless Steel —

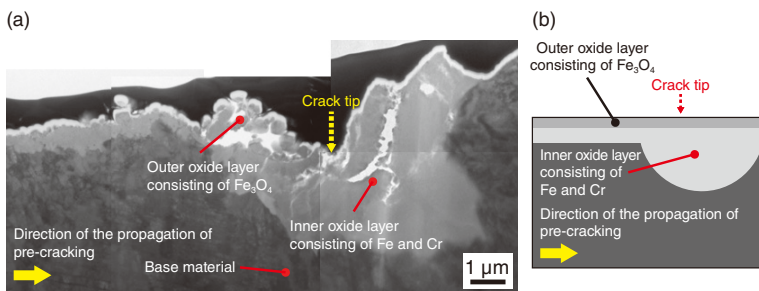
Fig.2-10 A cross-sectional image obtained by TEM (a) and a schematic illustration (b) near a crack tip for a 7-kN loaded CT specimen ($K = 30 \text{ MPa(m)}^{1/2}$) immersed in a simulated BWR coolant condition for 224 hours

An oxide inner layer was observed around the crack tip, where the strain and tensile stress were concentrated.

As shown in Fig.2-10, an outer oxide layer consisting of

magnetite (Fe_3O_4) and an inner oxide layer containing iron (Fe) and chromium (Cr) were observed inside the cracks in the immersed specimens. The characteristically thick inner layer was produced near the crack tip in loaded specimens (see Fig.2-10(a)). The thick oxide layer near the crack tip indicates that oxygen diffuses from the bulk water into the crack. However, the gap size of the crack during this immersion test was estimated to be less than $1 \text{ } \mu\text{m}$ by FEA. This narrow gap would inhibit the diffusion of oxygen dissolved in water to the crack tip, thus suppressing the oxide growth at the crack tip. The inner oxide layer observed in this study ($0.3 \text{ } \mu\text{m}$ after a 50-hour immersion) was much thicker than that observed in a previous study using unloaded specimens with a similarly narrow gap ($0.09 \text{ } \mu\text{m}$ after a 1000-hour immersion). Considering the strain near the crack tip simulated by FEA in Fig.2-9, dislocations, which are induced by the tensile stress, were concluded to provide diffusion paths for oxygen atoms.
