8-6 Change in Permeability after Backfilling a Research Tunnel

— Change in Hydraulic Conductivity in the Simulated Realistic Disposal Environment —

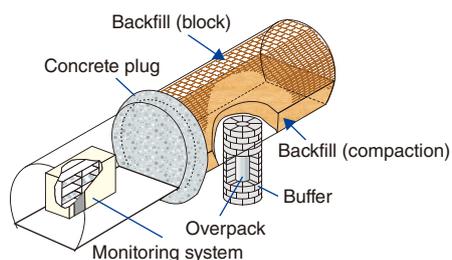
Fig.8-12 Illustration of the in situ engineered barrier system

The emplacement of the steel overpack, buffer material block, and backfilling were simulated.

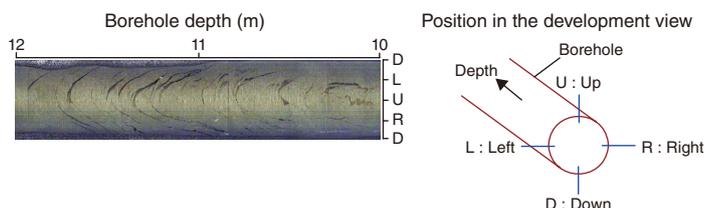
Fig.8-13 Development view of borehole wall image

Fractures were developed around the test pit in Section 2 (from 10 to 12 m).

A camera was installed in one of the drilled boreholes (H4-2; see Fig.8-13); camera imaging indicated fractures around the test pit. Therefore, the hydraulic conductivity of the EDZ around the test pit included Sections 2 and 3; Section 4 was maintained as an unfractured section, as indicated in Figs.8-13 and 8-14.

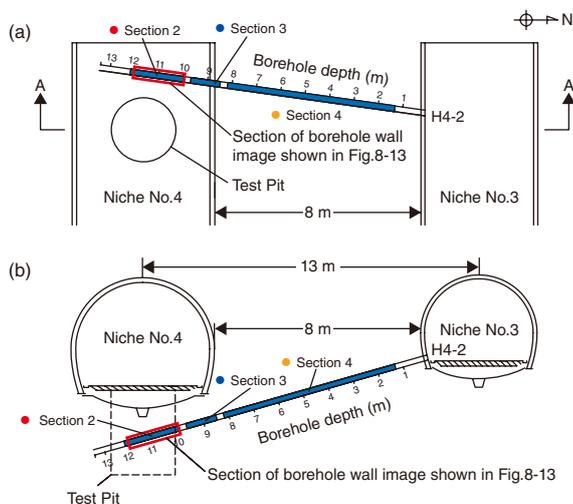
Fig.8-14 Layout of the hydraulic test: (a) plan view and (b) cross section

The construction of underground facilities induces fractures in the rock mass around the underground repository. This has particular implications for high-level radioactive waste (HLW) disposal projects, where fracture development creates an excavation-damaged zone (EDZ) that increases the hydraulic conductivity of the surrounding rock mass and can provide a pathway for migrating radionuclides from the disposal facilities. It is therefore necessary to develop a model that can estimate the future hydraulic conductivity of an EDZ and perform a comprehensive HLW-disposal safety assessment. In the Horonobe Underground Research Laboratory, an in situ engineered barrier experiment was designed to simulate a realistic disposal environment. In this experiment, which occurred from October 2014 to December 2014, the steel overpack and buffer material were placed and the gallery was partially backfilled (see Fig.8-12). Groundwater injections then began in January 2015. Additionally, hydraulic tests were performed for the following four years around the test pit to investigate the change in hydraulic conductivity.

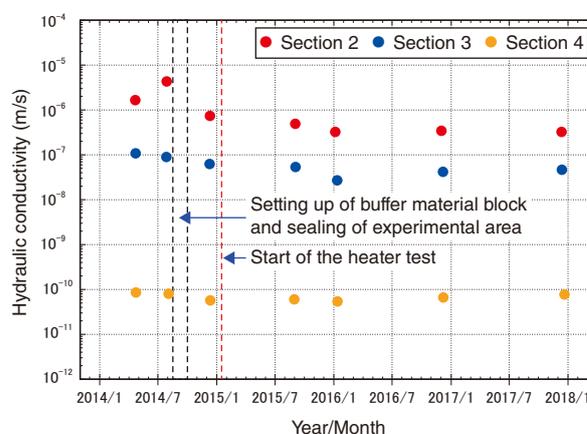
Fig.8-15 Simulated hydraulic conductivity

In Sections 2 and 3, the hydraulic conductivity slightly decreased from January 2014 to January 2016, but then remained constant.

The EDZ hydraulic conductivity in Sections 2 and 3 after the excavation of the test pit was $1.7\text{--}4.3 \times 10^{-6}$ and 8.9×10^{-8} to 1.1×10^{-7} m/s, respectively, representing values 3–5 orders of magnitude higher than those in the unfractured zone ($8.0\text{--}8.6 \times 10^{-11}$ m/s), as shown in Fig.8-15. In Sections 2 and 3, the hydraulic conductivity decreased by approximately one order of magnitude with time for the first two years, but then remained constant from January 2016. This suggests that the aperture of the EDZ fracture was not changed significantly, although the swelling of the buffer material did cause compression stress around the test pit. Therefore, these results provide fundamental data that will be instrumental in developing a model to predict the hydraulic conductivity of the EDZ.
