9-1 Direct Observation of Fractures to Estimate Future Permeability — Application of Fracture Visualization Technology by Resin Injection —

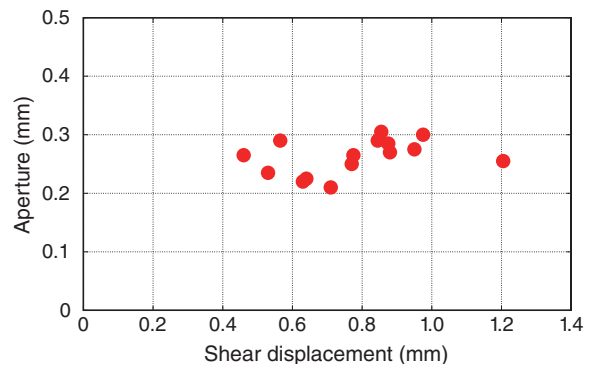
Fig.4 Relationship between shear displacement and aperture

Apertures of the EDZ fractures do not increase with an increase in shear displacement.

The measurement results showed that the aperture of the EDZ fracture did not increase with an increase in shear displacement. Therefore, it is estimated that the permeability of the fracture will not be affected significantly even if the buffer material swells after the backfilling of the gallery, causing deformation of the EDZ fracture. This result can be applied to improve the reliability of the evaluation of migration behavior of radionuclides from vitrified waste. In addition, this result can be helpful for the design of hydraulic plugs that can be built at the entrance of a gallery to prevent groundwater flow and radionuclide migration through the galleries after the facility is backfilled.
