5-9 What Accelerates Dissolution of High-Level Waste Glass? — Effects of Magnesium Ions in Solution—

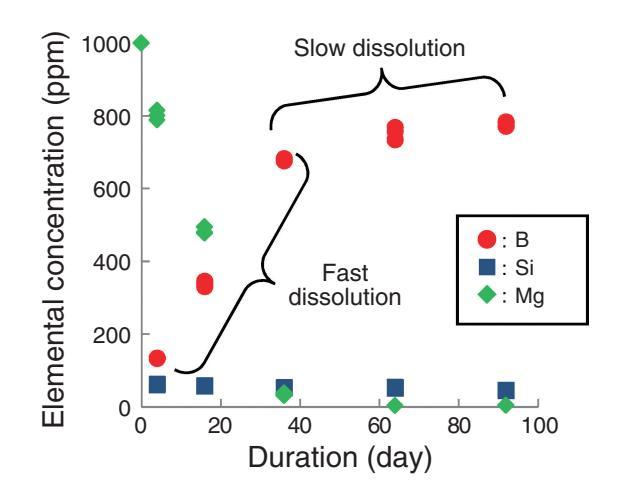
Fig.5-17 Elemental concentrations in the leachate versus time in the leach tests in MgCl₂ solution at 90 $^{\circ}$ C Boron (B) concentration is a quantitative indicator of glass dissolution. A higher glass dissolution rate is observed under the presence of Mg ions in leachate, while the rate drops after the depletion of Mg ions.

When Mg ions existed in the solution, the glass dissolved at a higher rate (Fig.5-17), and an altered layer including Mg and Si was observed on the surface of the leached glass (Fig.5-18).

The obtained results implied that glass dissolution at a higher rate during the first period of around 40 days was accompanied with the formation of magnesium silicates that consumed glass-network-forming Si. However, after this period, the rate decreased as Mg ions depleted in the solution because Si was not consumed to form magnesium silicates.

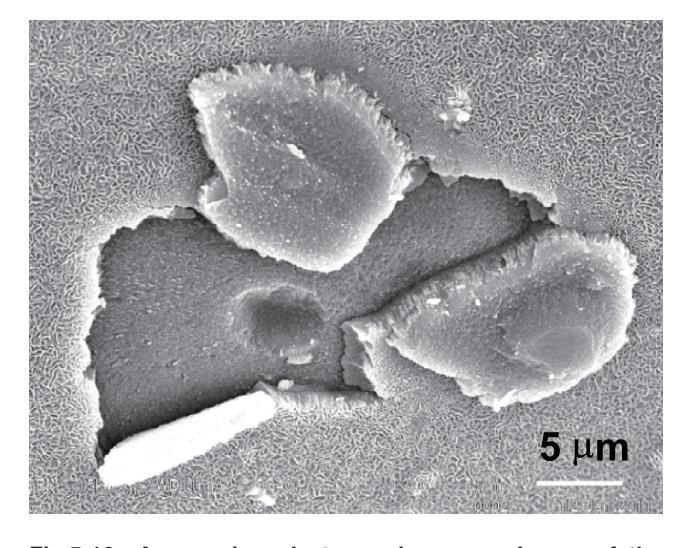
Fig.5-18 A scanning electron microscope image of the surface of glass leached in MgCl₂ solution at 90 °C It is observed that an altered layer is formed on the glass surface and is partially flaked off the surface. This altered layer measures around 1.0 μ m in thickness and mainly consists of Mg and Si.
