2-3 Refinement of Crack Growth Evaluation in the Reactor Internals of Light Water Reactors — Analyses of Locally Deformed Structures and Strain in Highly Irradiated Stainless Steels —

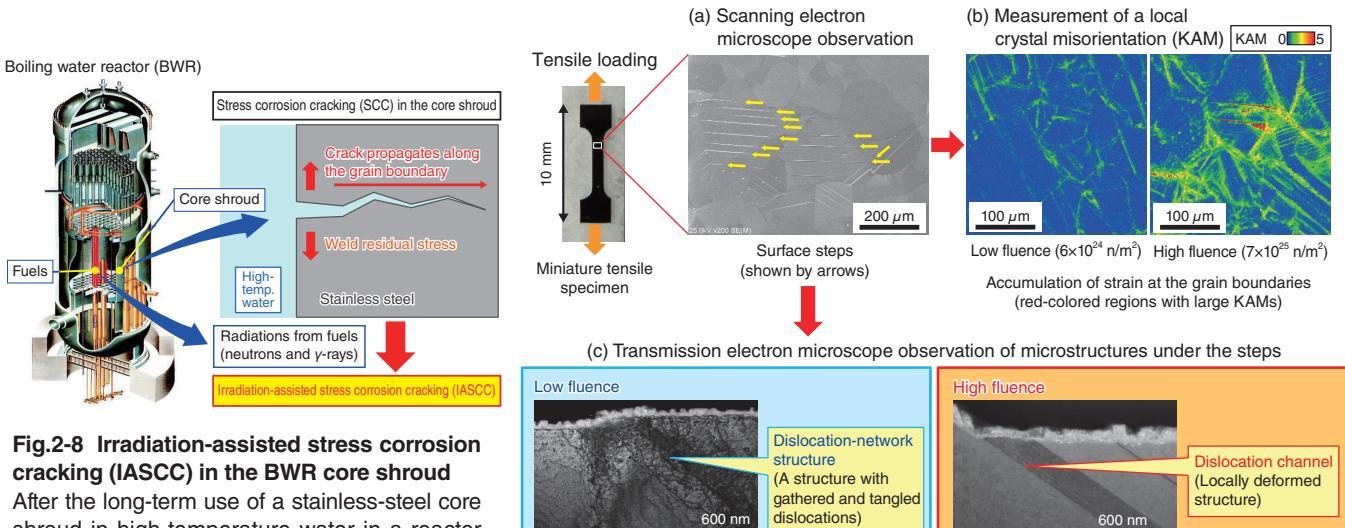
(a) In the specimen to which plastic deformation is applied through tensile loading, linear surface steps (shown by arrows) are formed. (b) For higher fluence, the local crystal misorientation (KAM) at the grain boundaries is larger and, therefore, a more remarkable accumulation of strain is implied. (c) The microstructure under the surface step is revealed to be a dislocation-network structure under low fluence but a dislocation channel under high fluence.

electron microscope. In addition, the local crystal misorientation (KAM), which indicates changes in the crystal orientation corresponding to the amount of plastic strain, was measured and the accumulation of local strain was quantitatively evaluated. As a result, linear surface steps appeared in the specimens by deformation, as shown in Fig.2-9(a). Moreover, as a result of detailed analysis of the relation between the distribution of KAM shown in Fig.2-9(b) and the crystal grains, we confirmed that KAM had a tendency to increase with an increase in the neutron fluence, especially at the grain boundaries. These results indicate that high strain is accumulated at the grain boundaries by deformation and that this effect is enhanced under higher fluence.

We selected a region near a grain boundary with a large KAM from each specimen and observed the cross-sectional microstructures under the surface steps using a transmission electron microscope. For the crystal grain under low fluence, a dislocation-network structure induced by deformation was observed just as in an unirradiated material, whereas under high fluence, a locally deformed structure called a dislocation channel was revealed (Fig.2-9(c)). From this result, we observed that localized deformation caused more remarkable surface steps attributed to the dislocation channels under higher fluence and that this was a cause of the accumulation of strain at the grain boundaries intersecting the surface steps. We will make good use of the knowledge obtained by the present study to further refine our evaluation of crack growth.
