## 7–1 Observation of Nuclides Adsorbed inside the Column Using Neutrons — Non-Destructive Visualization of Nuclides by Resonance Neutron Imaging —

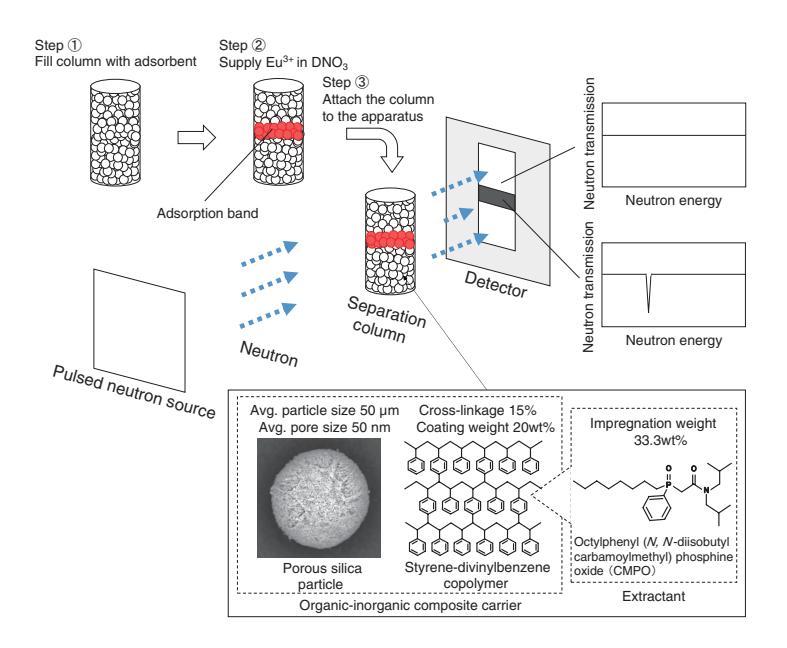
## Fig.7-2 Experimental resonance neutron imaging method

The organic-inorganic composite support, in which silica particles are coated with styrene-divinylbenzene copolymer, is impregnated by a CMPO extractant (or CMPO-impregnated adsorbent) and used to fill the separation column. The nuclides and their spatial distribution can be identified without destroying the sample from the neutron energy and the decrease in number of neutrons transmitted through the column, respectively.

A schematic of the neutron irradiation experiment performed at J-PARC is shown in Fig.7-2. The column was irradiated with neutrons, and the transmitted neutrons were measured by a detector. The neutron energy was determined by the flight time of neutrons from the pulsed neutron source to the detector, and the nuclides and their spatial distribution were identified from the neutron absorption energy and the decrease in the number

of neutrons after transmission, respectively. These data were converted to a neutron radiograph, which allowed us to observe the internal structure of the column without destroying it.

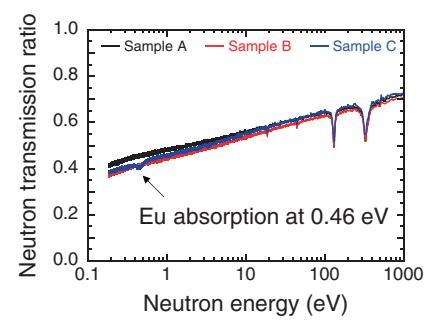
Fig.7-3 Measured neutron transmission

The ratio of neutrons transmitted through the column is shown with respect to neutron energy. The column was found to contain W, Mo, Co and Mn nuclides.

When light water (H<sub>2</sub>O) is used in neutron radiography, neutrons react with hydrogen, causing low transmittance and a low-resolution neutron radiograph. This problem was solved by using deuterium. The obtained neutron transmission spectra of the columns filled with (A) D<sub>2</sub>O, (B) DNO<sub>3</sub>, and (C) Eu<sup>3+</sup> after being prepared with DNO<sub>3</sub> are shown in Fig.7-3. Replacing H<sub>2</sub>O with the deuterium solvent increased the neutron transmission from 20% to 50%. A characteristic decrease of neutrons was observed at 0.46 eV, as shown in Fig.7-3(C). This value is nuclide-specific, thereby providing evidence of the presence of Eu-151. The Eu adsorption band was also confirmed in the neutron radiograph, as indicated in Fig.7-4.
