## 8-4 Rationalization of the Structural Design of Nuclear Components under Exposure to Intense Irradiation

— Development of a Concept for Assuring Integrity Applicable to Components with Reduced Ductility Due to Intense Irradiation —

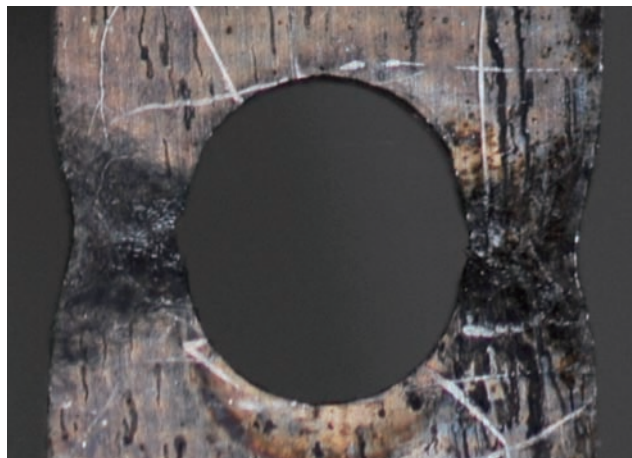
**Fig.8-11 Deformation behavior of an intensely irradiated structure with a discontinuity**

The structure with a hole in the center (initial diameter of the hole was approximately 2.5 mm) subjected to tensile loading shows that the center part of the structure (ligament) became unstable, leading to necking, similar to a simple tensile specimen according to the JIS standard. No cracking was observed on the surface at the maximum strain point (or at the edge of the circular hole).

Next, for each failure mode, we considered what kinds of limiting parameters should be selected for generating design allowable limits. The key conclusion is that the limiting parameter should be selected by considering which occurs first: localized deformation due to tensile plastic instability, or crack initiation. Systematic selection criteria were then developed for application to a wide range of ductility. The applicability of the selection criteria was not clear in structures with discontinuous configurations which cause complicated deformation behavior, and tensile testing of an intensely irradiated structure with a discontinuity was conducted. The discontinuity was a circular hole in the center of a flat plate. The deformation of the structure just before fracture is shown in Fig.8-11. After passing the maximum load point, the plastic deformation became unstable and localized, and at that time no crack initiation was observed on the surface. Such a localized deformation or necking is often observed in tensile testing of a simple tensile test specimen according to the Japanese Industrial Standards (JIS). Accordingly, it can be concluded that the selection criteria are applicable to structures with actual configurations.
