2-1 Fuel Failure Processes Revealed by Numerical Approach

- Simulation of Fracture Behavior Using Damage Mechanics Model -

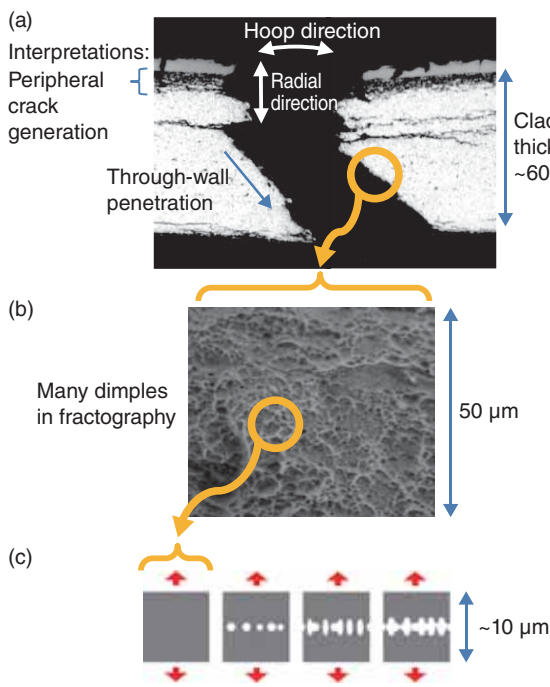
Fig.2-3 Failure of long-term used fuel cladding and modelling

(a) We anticipated that peripheral cracks are at the origin of the observed cladding failure. (b) Many dimples indicate that fracture occurred in a ductile manner. (c) The cladding was modeled as an assembly of elements that break upon finite deformation.

To overcome this difficulty, we developed a numerical model of fuel cladding to simulate a RIA. The cladding was modeled as an assembly of elements (Fig.2-3(c)), each about 10 μm in size. This element was designed to break upon finite deformation, as determined independently of the RIA tests.

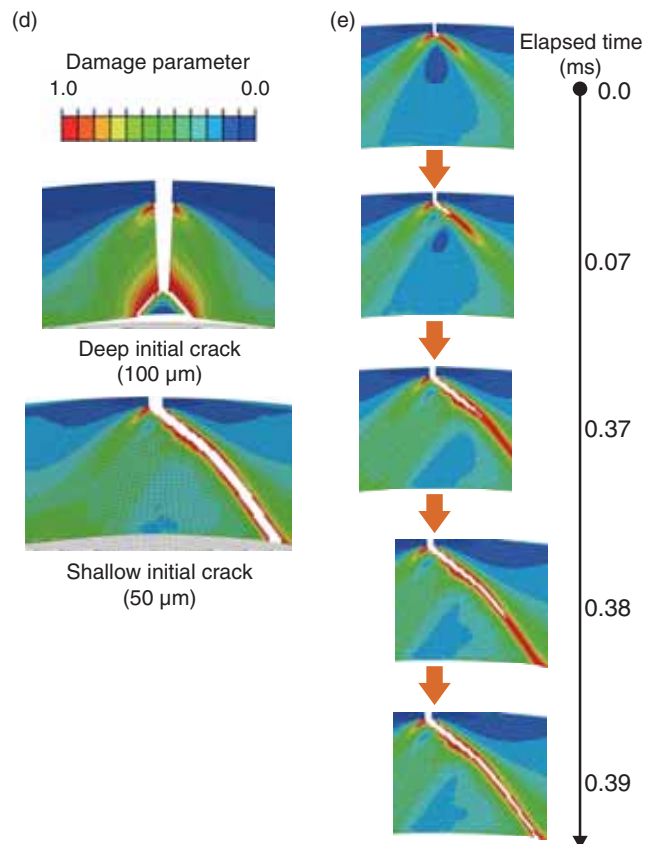
Fig.2-4 Simulation results

(d) Fracture appearance depends on initial crack length.
(e) Penetration through the wall with very small increment in time (and strain).

The simulation well reproduced the observations: fractures characterized by a predominant ductile shear in the shallow-crack case and straight-crack propagation in the deep-crack case (Fig.2-4(d)), and penetration through the wall that occurs in a very short time (<1 ms) (Fig.2-4(e)). This result strongly supports the aforementioned hypothesis and reveals that predominant ductile shear (Fig.2-3(a)) occurs when a softened region extends along the strain field around the crack tip and collapses simultaneously at a certain deformation. A sensitivity analysis using the model provides information on the influence of the loading state and temperature distribution inside the cladding on the failure limit, which supports the ongoing development of methods for safety evaluation that can accurately predict the failure limit of long-term used fuels.
