# 1-14 Maintaining the Integrity of the Reactor Vessel until the Completion of Fuel Removal

## — The Influence of Radiation on the Corrosion of Vessel Steels and Corrosion Measures —

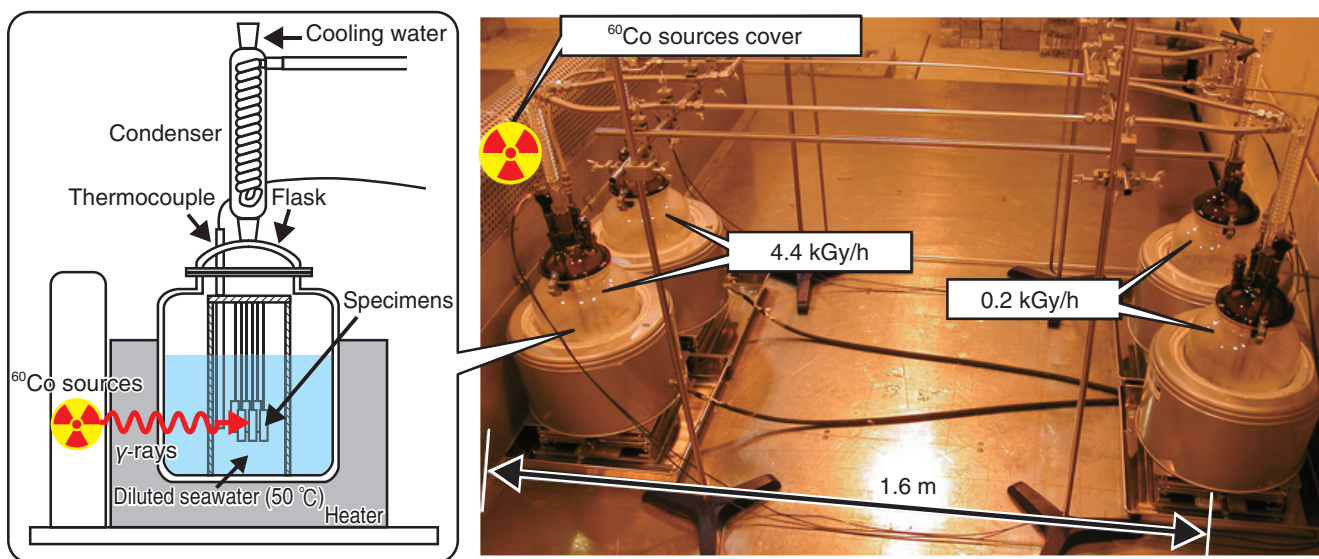
**Fig.1-30 Corrosion testing of steel specimens under  $\gamma$ -ray irradiation**

To simulate the conditions inside PCVs, corrosion testing of steel specimens in diluted seawater under  $\gamma$ -ray irradiation was conducted.

As shown in Fig.1-30, specimens of SGV480 steel—identical to the actual steel used in the PCV—were immersed in diluted artificial seawater and irradiated by  $\gamma$ -rays for 500 h. Fig.1-31 shows the results of the corrosion test under irradiation. “Corrosion weight loss” on the vertical axis is the weight lost by

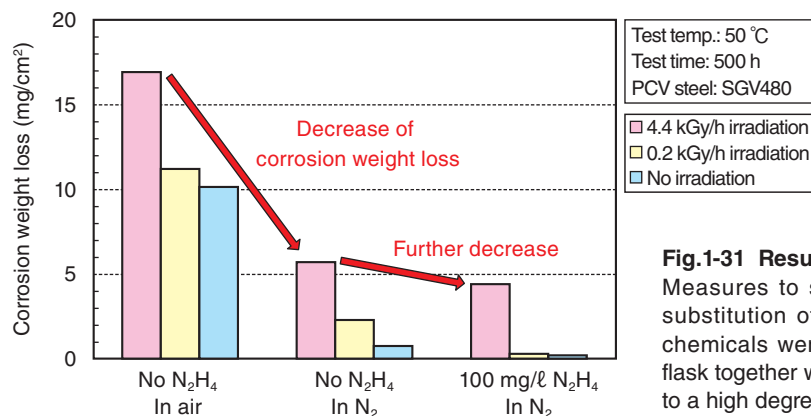
**Fig.1-31 Result of the corrosion test of PCV steel**

Measures to suppress the corrosion of steel by nitrogen substitution of the gas phase of PCV and the addition of chemicals were examined. The nitrogen substitution in the flask together with hydrazine addition could suppress corrosion to a high degree.

the specimen due to corrosion, and was obtained by removing the rust from the specimen, weighing it, and comparing the result to that obtained before the specimen's immersion. After the accident at 1F, nitrogen gas was enclosed in PCVs for the purposes of preventing hydrogen explosions. Corrosion tests under irradiation in the test flask in which nitrogen gas was enclosed showed a decrease of the weight loss, as shown in Fig.1-31. Since the oxygen partial pressure of the gas phase in the flask decreased through nitrogen substitution, the concentration of dissolved oxygen in the diluted seawater also decreased, and consequently the corrosion rates of specimens decreased as well. Furthermore, the case that used nitrogen substitution together with the addition of hydrazine with the property of removing oxygen from water is shown on the right-hand side of Fig.1-31. From this result, it is believed that the corrosion of PCVs, wherein nitrogen is enclosed and hydrazine has been injected, is still under control at present.
