7-2 Aiming for Robustness for the Reactor Building to Withstand Severe Natural Disasters – Evaluation of External Hazards to the Reactor Building –

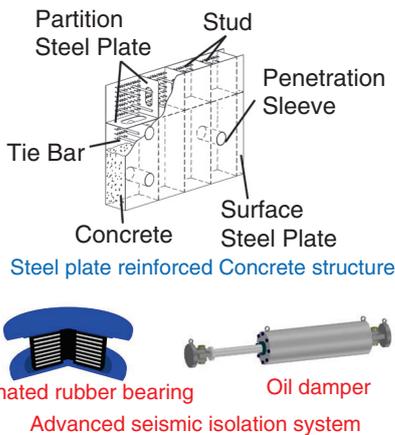
Fig.7-4 Steel plate reinforced concrete (SC) structures and the advanced seismic isolation system

SC structure comprising a pair of steel plates with a concrete filling in between, and an advanced seismic isolation system with laminated rubber bearings and dampers have been investigated.

A steel plate reinforced concrete (SC) structure has been considered for the building wherein the sodium-cooled fast reactor (SFR) is housed. The SC structure comprises a pair of steel plates with a concrete filling in between, held together by studs, etc. In addition, an advanced seismic isolation system with laminated rubber bearings and oil dampers has been investigated for adoption against earthquakes (Fig.7-4).

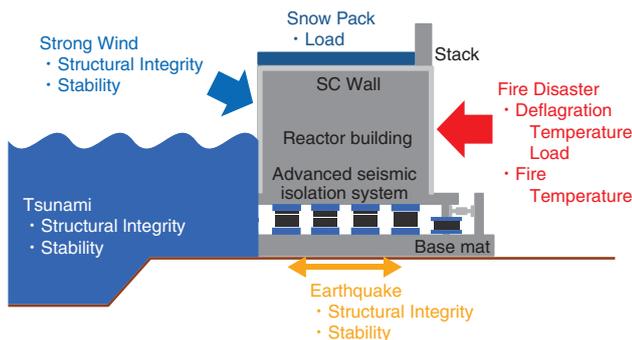
Fig.7-5 Evaluated external hazards

The evaluated external hazards were earthquake, tsunami, snowpack, strong wind, and fire disaster.

In response to the Great East Japan Earthquake and the accident at the TEPCO’s Fukushima Daiichi NPS in March 2011, the structural integrity and stability of reactor buildings against external hazards have been re-evaluated. Fig.7-5 shows the evaluations for earthquake, tsunami, snowpack, strong wind, and fire. These external hazards are threats to the structural integrity and stability of the reactor building; hence, to protect the safety of a reactor building, it must be constructed in such a
