## 9-5 Disassembly of the Japan Torus-60 Tokamak Device for the Japan Torus-60 Super Advanced Project — Disassembly of Large Radioactivated Structures —

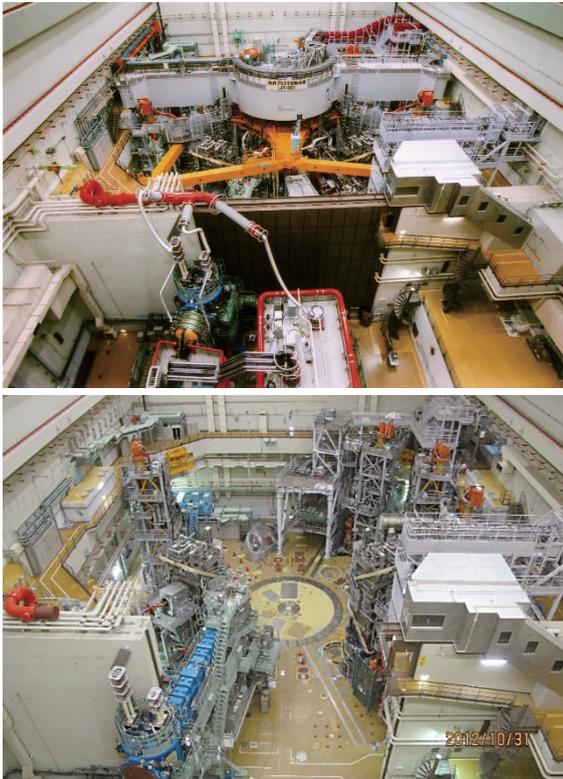
**Fig.9-14 JT-60 Torus hall after disassembly**  
Disassembly of the JT-60 tokamak was completed without accidents in October 2012. Assembly of JT-60SA started in January 2013.

The disassembly of the JT-60 tokamak device (Fig.9-13) was required for the construction of the JT-60SA tokamak as part of the Satellite Tokamak program conducted in collaboration between Japan and the EU. The JT-60 tokamak was a unique fusion device regulated by the Radiation Hazard Prevention Act. This device had been radioactivated by neutrons during deuterium operations between 1991 and 2008. This disassembly was the first such experience with a large, radioactivated fusion device in Japan, and represented a new approach in consideration of the application of clearance level regulations in the future. The disassembly started in 2009 and was completed in October, 2012. The total weight of the dismantled components reached up to 5400 tons (Fig.9-14).

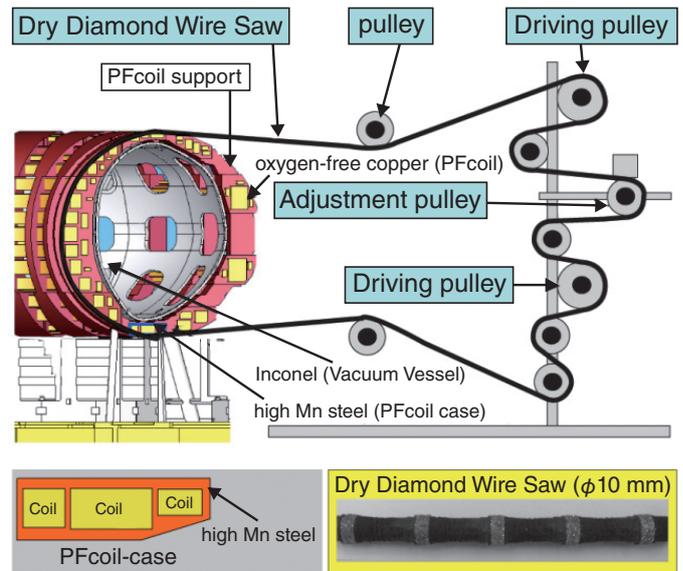
**Fig.9-15 Diamond wire-saw system**

The diamond wire saw is an embedded diamond chip. It can efficiently cut dissimilar metals without cooling water.

After removing the TFCs, the main residual components were the vacuum vessel and the PFCs. Their total weight was about 320 tons, which was beyond the building crane capacity (250 tons). The residual component was to be separated into two parts for lifting. The materials of the VV and the PFCs were Inconel and oxygen-free copper supported with high-Mn steel, respectively. In this case, matrix structures were to be simultaneously cut. In the mock-up test, it was found that a dry diamond wire saw could cut those materials without cooling water. Finally, the application of the dry diamond wire saw to the separation was successfully conducted (Fig.9-15).
