4-4 Vacancies Studied by Positron Annihilation Lifetime and Hydrogen Adsorption — Hydrogen Embrittlement under Elastic Stress of High-Strength Steel —

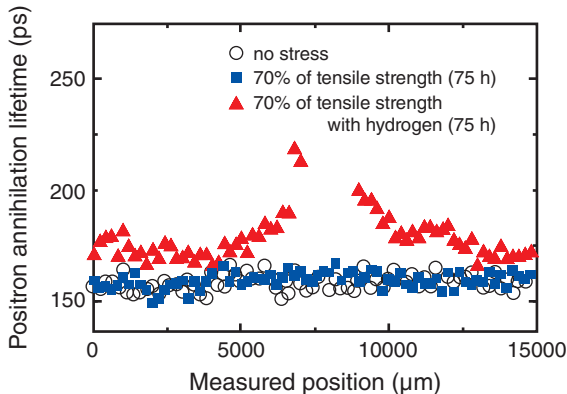
Fig.4-9 Specimens for positron annihilation lifetime measurements

Every arrow indicates the measured area for each specimen. The color of every arrow corresponds to the color of the plots in Fig.4-10.

vacancies (vacancy cluster). The steel specimens (Fig.4-9) loaded with 70% tensile strength for 75 h with and without hydrogen were evaluated by the positron annihilation lifetime. As shown in Fig.4-10, the positron annihilation lifetime was longer only with hydrogen, probably because of vacancy formation. In addition, the positron annihilation lifetime is longer still in the vicinity of the broken part because larger vacancy clusters might be formed there.
