2-2 Evaluating the Degree of Deformation of the Fuel-Cladding Tube during Loss-of-Coolant Accidents — Effect of Oxidation and Crystal-Phase Condition of the Cladding Tube —

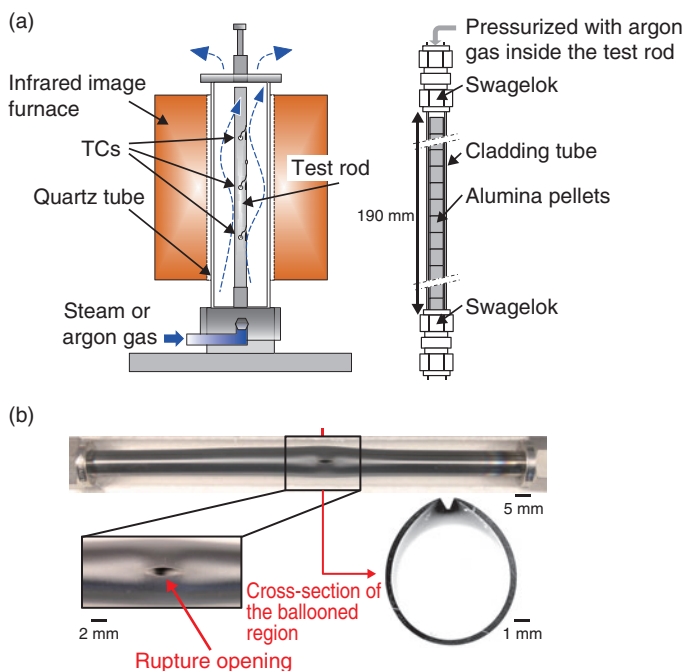
Fig.2-6 (a) A schematic of the test apparatus used for a simulated LOCA test; **(b)** The appearance and cross-sectional macrograph of the ballooned region of a typical post-test cladding-tube specimen
(a) A test rod is heated by an infrared image furnace in steam or argon-gas flow inside the quartz tube at a rate of ~ 3 K/s, close to the heating rate of a fuel rod in a typical postulated LOCA sequence. During the heat-up phase, the cladding tube balloons and ruptures due to a decrease in cladding mechanical strength and an increase in rod internal pressure. (b) The area of the rupture opening was estimated from the post-test appearance of the ruptured cladding tube, and the maximum circumferential strain was evaluated based on the macrograph of the cross-section at the largest ballooned region of the post-test cladding tube.

Simulated LOCA tests were conducted on non-irradiated Zircaloy-4 cladding tubes using the test apparatus shown in Fig.2-6(a) to investigate the ballooning size and rupture-opening area of the post-test cladding tube (Fig.2-6(b)). Steam

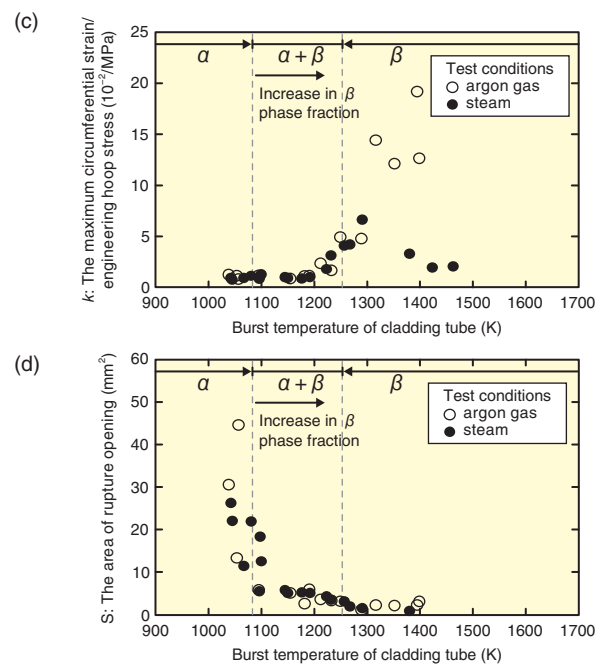
Fig.2-7 Results of burst test under simulated LOCA conditions
Symbols α , $\alpha+\beta$, and β show the crystal-phase conditions of Zircaloy-4, namely the α phase, the $(\alpha+\beta)$ phase, and the β phase, respectively. (c) The maximum circumferential strain, which was divided by the circumferential stress at the burst of the cladding tube (k), tended to increase as the burst temperature approached the β -phase region. When the burst temperature reached this region, a difference in k was observed between the steam and argon gas conditions. (d) The area of the rupture opening in the α -phase region tended to be larger than that in the burst-temperature region where the β phase existed.

To eliminate the effect of the rod-internal pressure at burst, the maximum circumferential strain which was divided by the nominal stress just before the burst of cladding tube, k , tended to increase as the burst temperature approached the β -phase region (Fig.2-7(c)). In contrast, when the burst temperature reached this region, k tended to increase in the argon-gas condition and decrease in the steam condition with increasing burst temperature. These results suggest that the embrittlement of the cladding tube due to oxidation affects the ballooning and rupture behaviors of the tube in this burst-temperature region. In addition, based on the relationship between the area of the rupture opening and the burst temperature of the cladding tube, it is found that the area of the rupture opening in the α -phase region tended to be larger than that in the burst-temperature region where the β -phase existed (Fig.2-7(d)).
