6-6 Proving the Seismic Integrity of the High-Temperature Gas-Cooled Reactor

— Integrity Confirmation of Graphite Components by Seismic Evaluation and Visual Inspection —

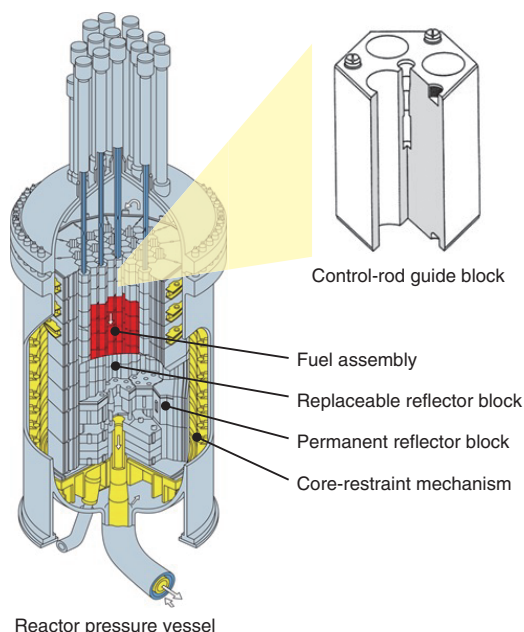
Fig.6-11 Reactor pressure vessel and control-rod guide block of the High-Temperature Engineering Test Reactor (HTTR)

This figure shows the control-rod guide block and a cutaway view of the reactor pressure vessel. The reactor components comprise graphite blocks such as control-rod guide blocks, fuel assemblies, permanent reflector blocks, and replaceable reflector blocks, all of which are installed in the reactor pressure vessel.

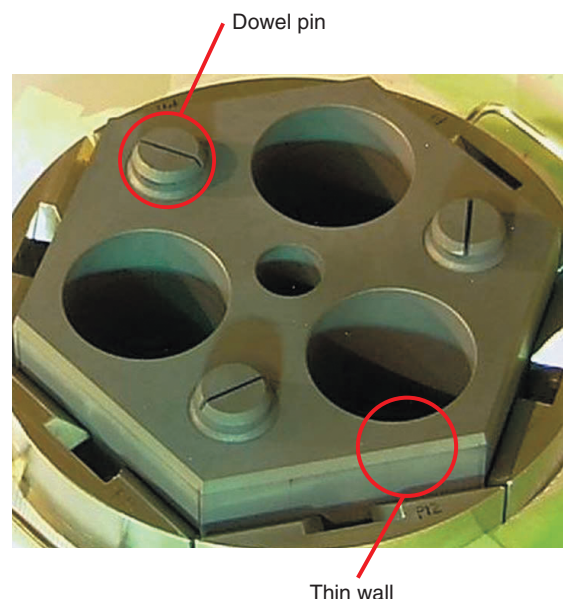
Fig.6-12 Visual inspection of the control-rod guide block

Control-rod guide blocks in the reactor pressure vessel were taken out in order to exchange neutron startup sources. An inspection of the control-rod guide block was conducted for the first time after the Great East Japan Earthquake. The integrity of the control-rod guide block was confirmed, and positive proof was acquired from the result of seismic analysis.

Neutron-startup sources were exchanged in HTTR in October 2015. The control-rod guide blocks, wherein the neutron startup sources were installed, were taken out from the reactor core and visually inspected subsequently, as shown in Fig.6-12. The reactor components were taken out for the first time since the 3.11 earthquake, providing a good opportunity to confirm the seismic integrity directly. As a result of the visual inspection, it was confirmed that there was no damage to the whole block surface, including the thin wall and the dowel pins where seismic force was concentrated upon the control-rod guide block.
